ACORN

Advanced Coatings for Offshore Renewable Energy

Deliverable D5.1: At least one coating from WP3 has been successfully demonstrated in a marine environment and has exhibited fouling and seawater corrosion resistance over one summer season.

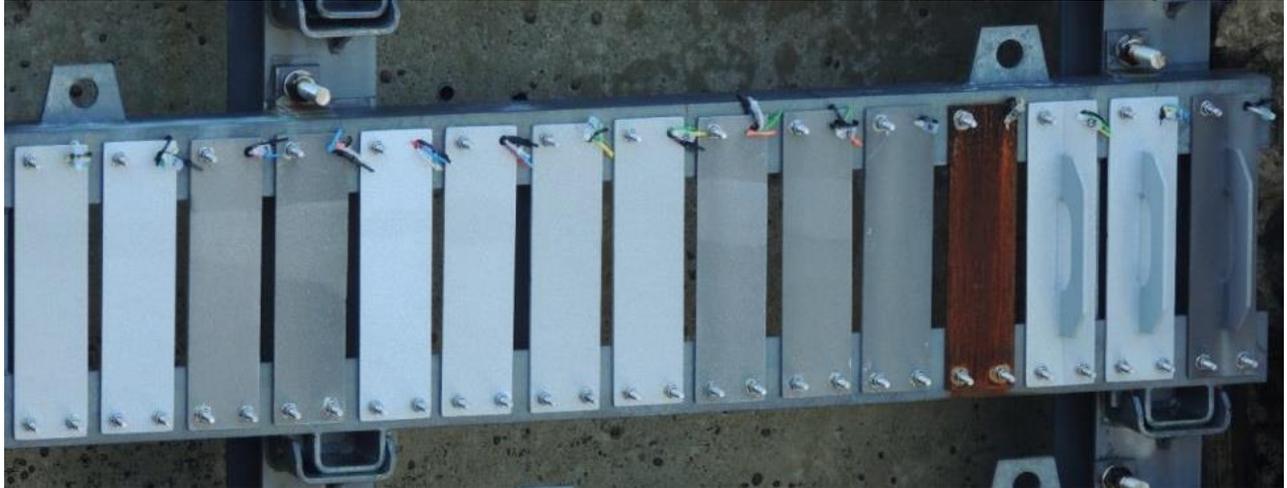
Splash: all the specimens have the same visual aspect than they had in the installation except the one without TSA (see Figure 10). It is observed that coupon 15 (C15) (the first specimen on the right) has been discolored at one side of the welded part.

Figure 10: Samples in splash zone 18 days after installation

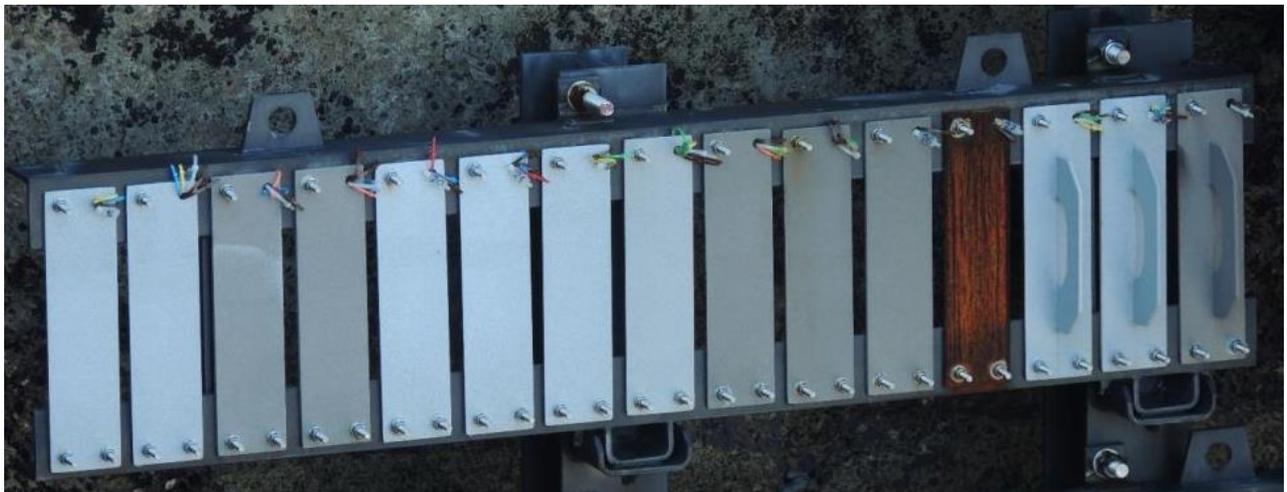
Tidal: Figure 11 shows the presence of rust in the upper screw of C25, which was the sixth coupon from the right, probably dropped from C12 (coupon without TSA in the splash zone just over C25). This rust had possibly activated the presence of algae in the coupon as it is showed in Figure 12. Figure 11 shows the first rust traces and Figure 12, taken ten days later, shows more rust and a larger presence of algae.

Figure 11: Samples in the tidal zone 18 days after installation

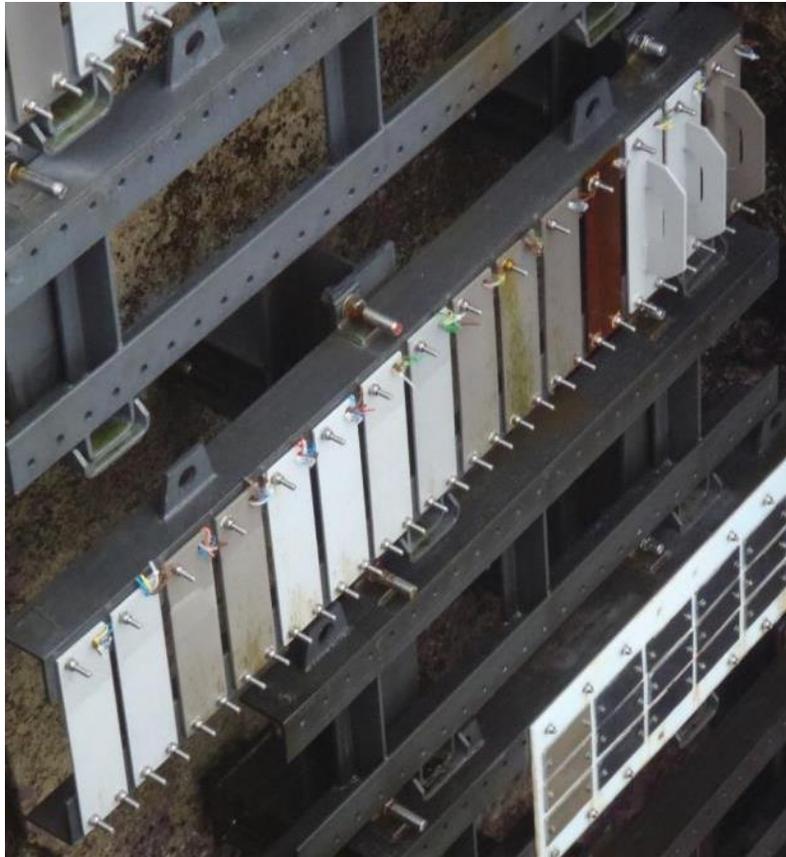
In addition to it, algae were appearing at the bottom of the following coupons: C18 and C19 (same coating system) and C20 and C21 (same coating system) (see Figure 12).

Figure 12: Samples in the tidal zone 10 days after Figure 11 was taken

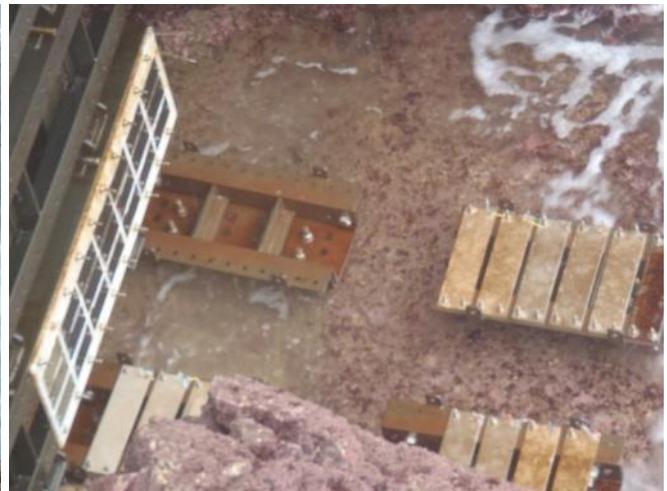
Submerged: Figure 14 shows a substance similar to mud covering all the specimens. No green algae were present on these coupons. The quality of the image is not so good due to the weather conditions

Figure 14: Samples in submerged zone 10 days after Figure 13 was taken

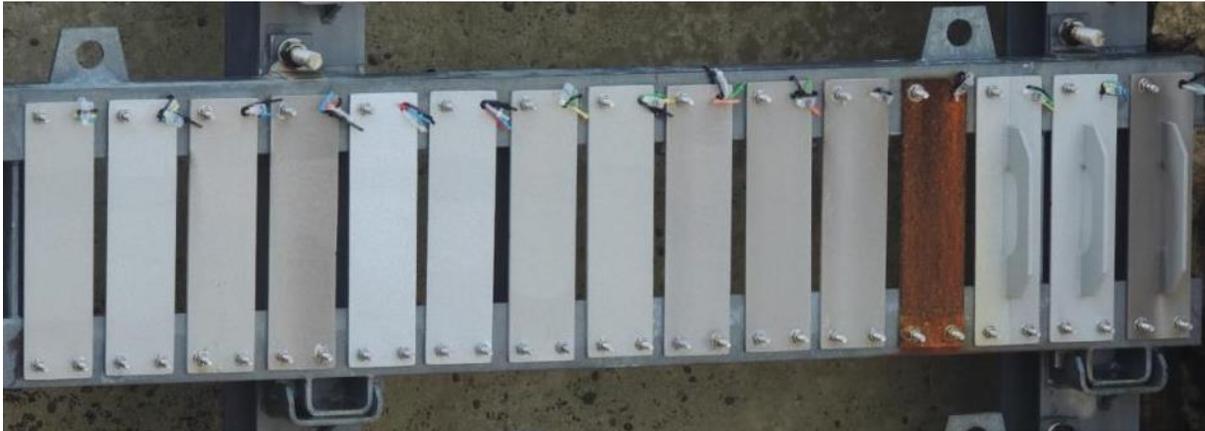
Splash: all specimens had the same visual aspect than they had in Month1 (M1). Figure 15 shows an important difference of color between C3 and C4 (third and fourth sample from the left) which were protected with the same coating system.

Figure 15: Samples in the splash zone in M2

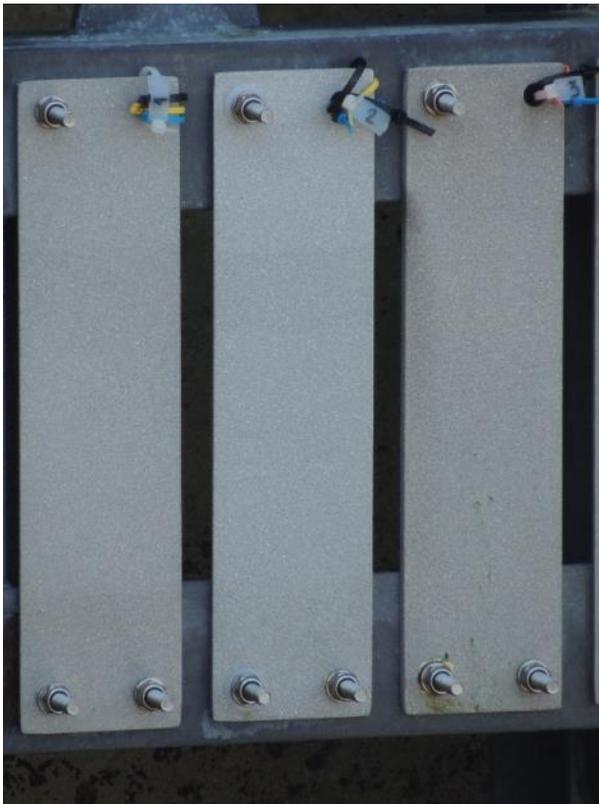
Traces of algae were observed in the lower part of C3 (see Figure 16). C15 continued being discolored at one side (right side) of the welded handle. There was also algae stuck behind C1 (see Figure 17).

Figure 16: Traces of algae in lower zone of C3 (sample on the right)

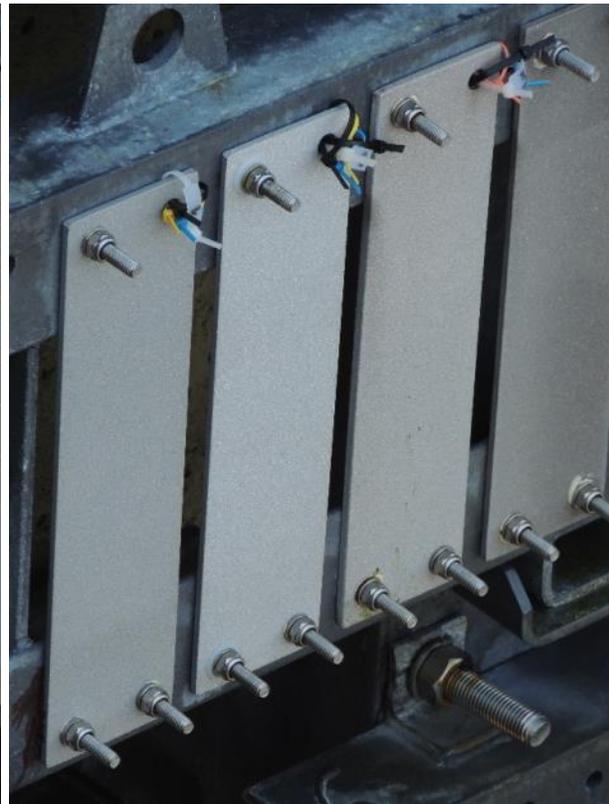
Figure 17: Algae stuck behind C1 (first sample on the left)

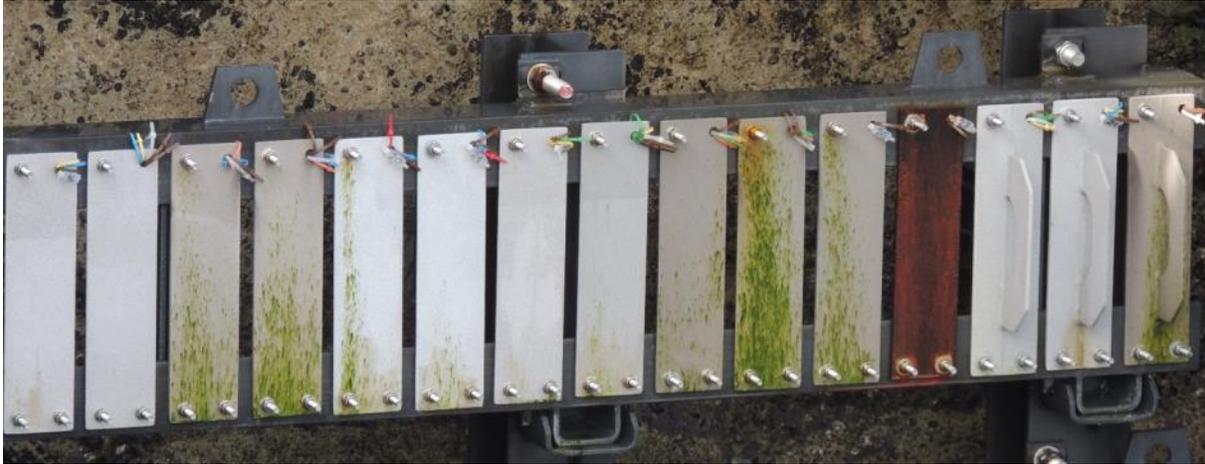
Tidal: there were more coupons with algae than in the previous month of exposure, M1. C16 and C17 were the only flat samples that did not have algae in their surface. The three welded coupons had algae although C30 was the one most influenced by this phenomenon. Figure 18 shows how the presence of algae began below the upper screw (C20 and C26). It might be because water drops fell from the screw once the wave has gone.

Figure 18: Samples in the tidal zone in M2

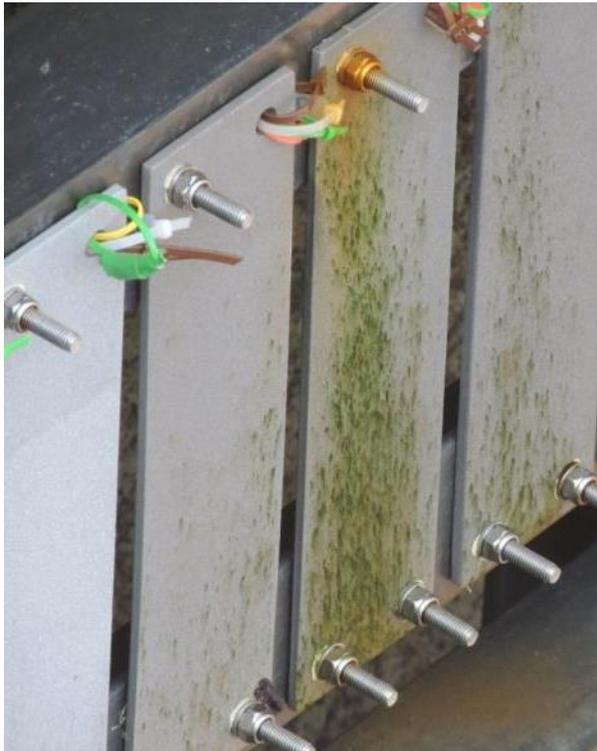
Figure 19 shows a limpet on the lower part of C24 and the significant presence of algae in C25. Figure 20 shows the way a limpet followed to feed itself (lack of algae in the sample).

Figure 19: A limpet next to the screw on C24 (second sample from the left)

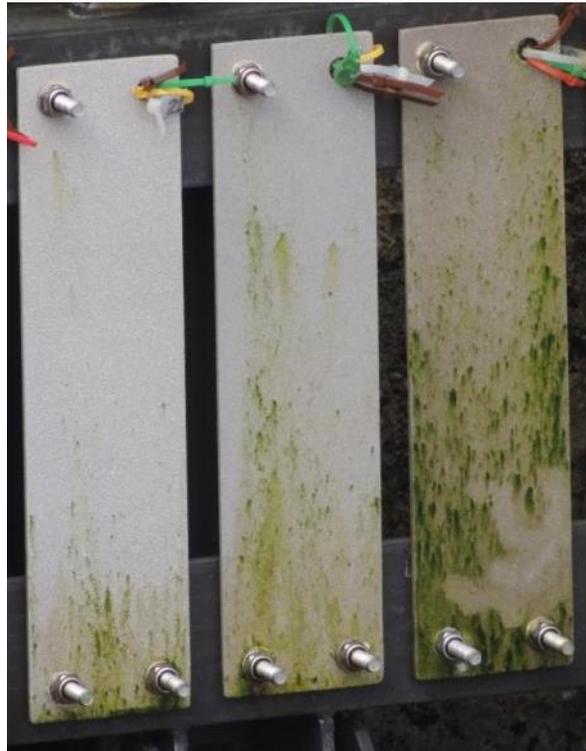
Figure 20: Path followed by a limpet to feed itself in C24 (first on the right)

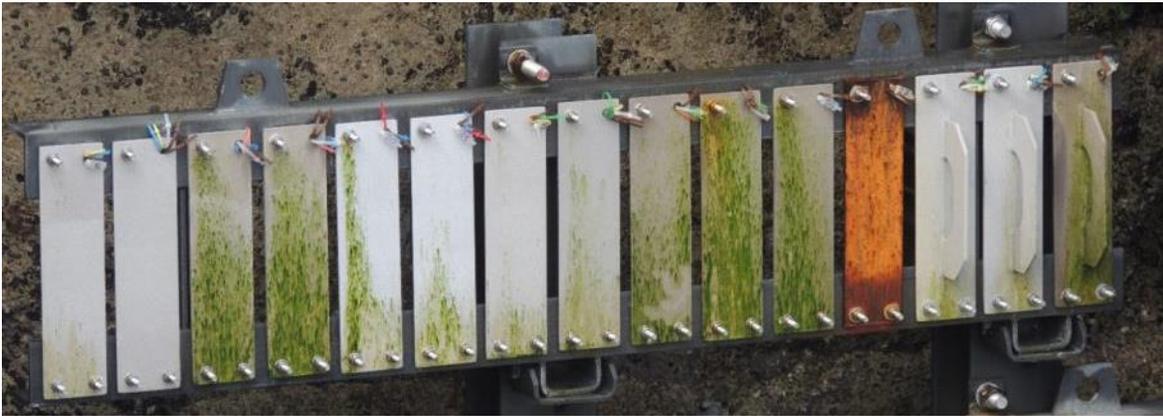
Figure 21 was taken only 8 days after Figure 18 and a difference on the quantity of algae on coupons was noted, it had been increased in this short period of time. For example C28 and C29 (welded coupons) did not have algae previously and now they do.

Figure 21: Samples in the tidal zone 8 days after Figure 18 was taken

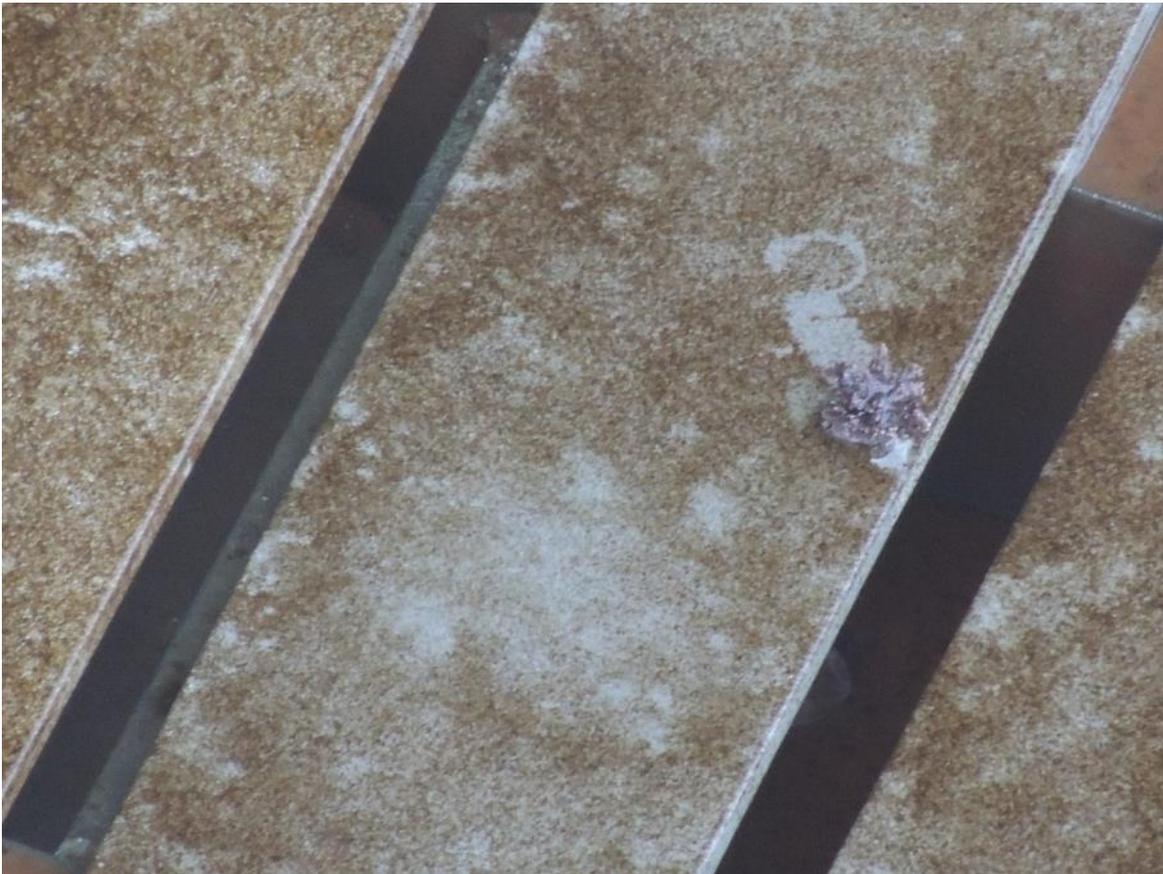
Submerged: Figure 22 shows a limpet on C39. The limpet cannot be distinguished because there was algae on it. This image also shows the possible way the limpet followed for feeding itself. It indicates that the brown substance on coupons and frames had a vegetal origin and it was not rust as it could be thought the first time this substance appeared.

Figure 22: Detail of a limpet on C39

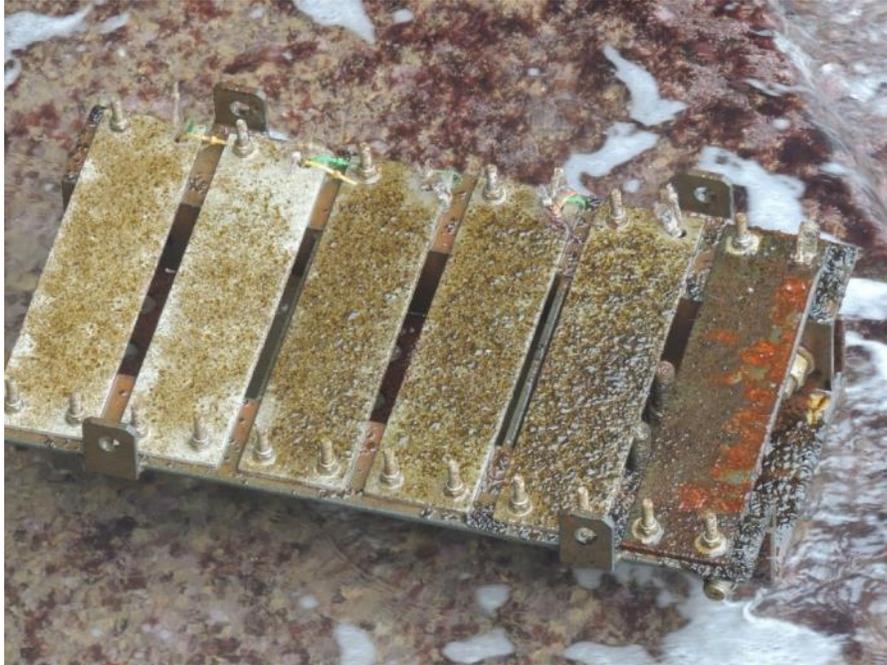
Figure 23 shows brown algae on the coupons and on the frame. It is noted that the quantity of algae on submerged coupons had been increased considerably in 26 days, the time between when Figure 22 and Figure 23 were taken. It can be a normal phenomenon because the temperature of water and the light time had been increased from previous months.

Figure 23: Samples in the submerged zone covered by brown algae

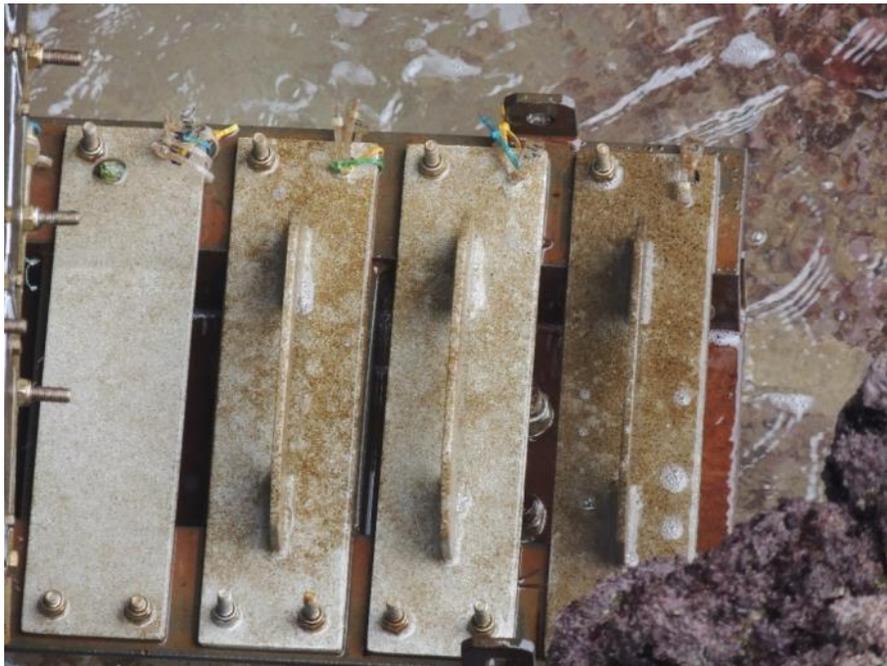
Figure 24 shows a limpet next to the screw on C32 (left side). In this case there was no evidence of lack of brown algae on the sample which could indicate a way followed by the limpet.

Figure 24: Detail of a limpet on C32

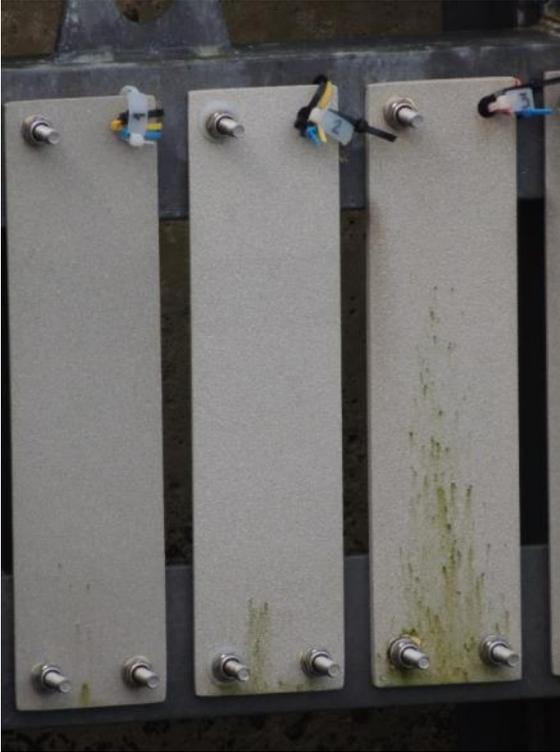
Splash: more quantity of algae were observed in the lower part of C3 and some traces of it were observed in C1 and C2 (see Figure 25) and C6 (Figure 26).

Figure 25: Samples C1, C2 and C3 (from left to right respectively)

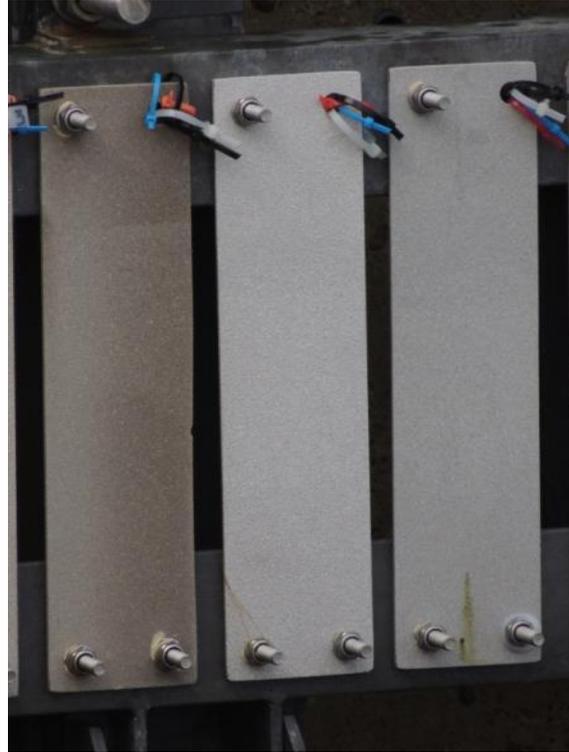
Figure 26: Traces of algae in C6 (first on the right)

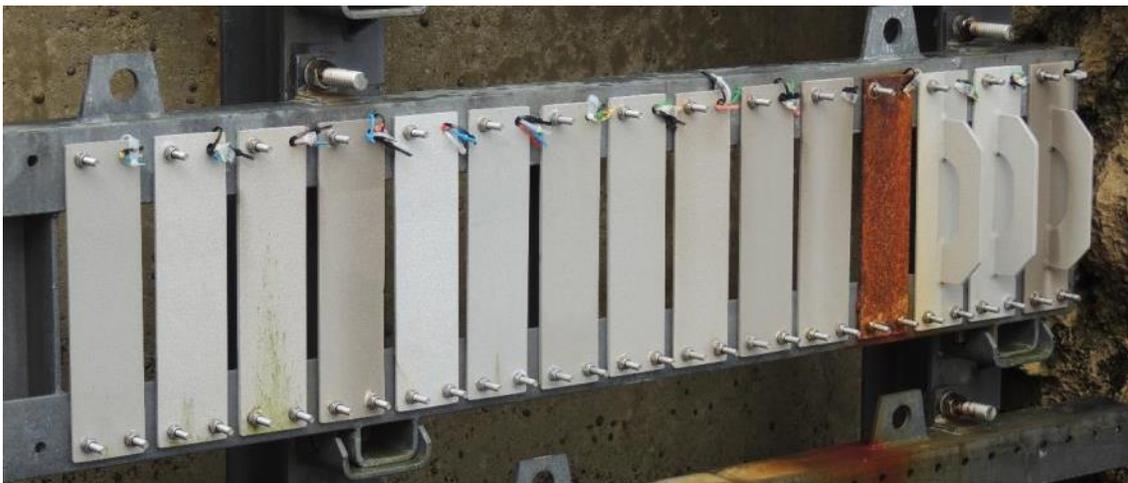
Figure 27 shows an important difference of color between C3 and C4, having their coatings the same composition, and C15 continued being discolored at one side of the welded part (right side).

Figure 27: Samples in the splash zone in M3

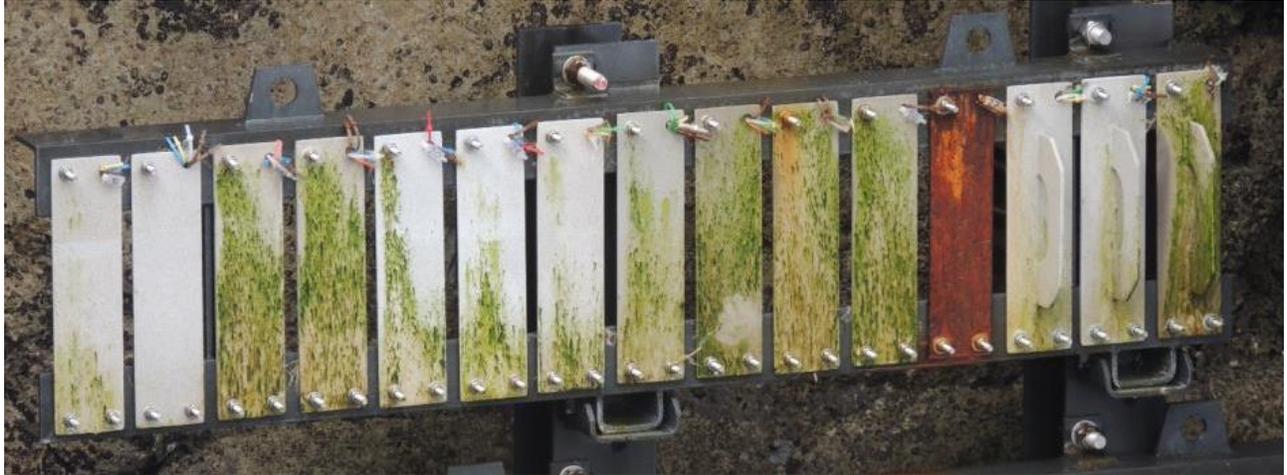
Tidal: Figure 28 shows how C17 was the only coupon that did not have algae on its surface. The three welded coupons had algae although C30 was the most influenced by this phenomenon. It was also noted how the presence of algae began below the upper screw. It might be, as it has been mentioned previously, because the water drops fell from the screw once the wave had gone.

Figure 28: Samples in the tidal zone in M3

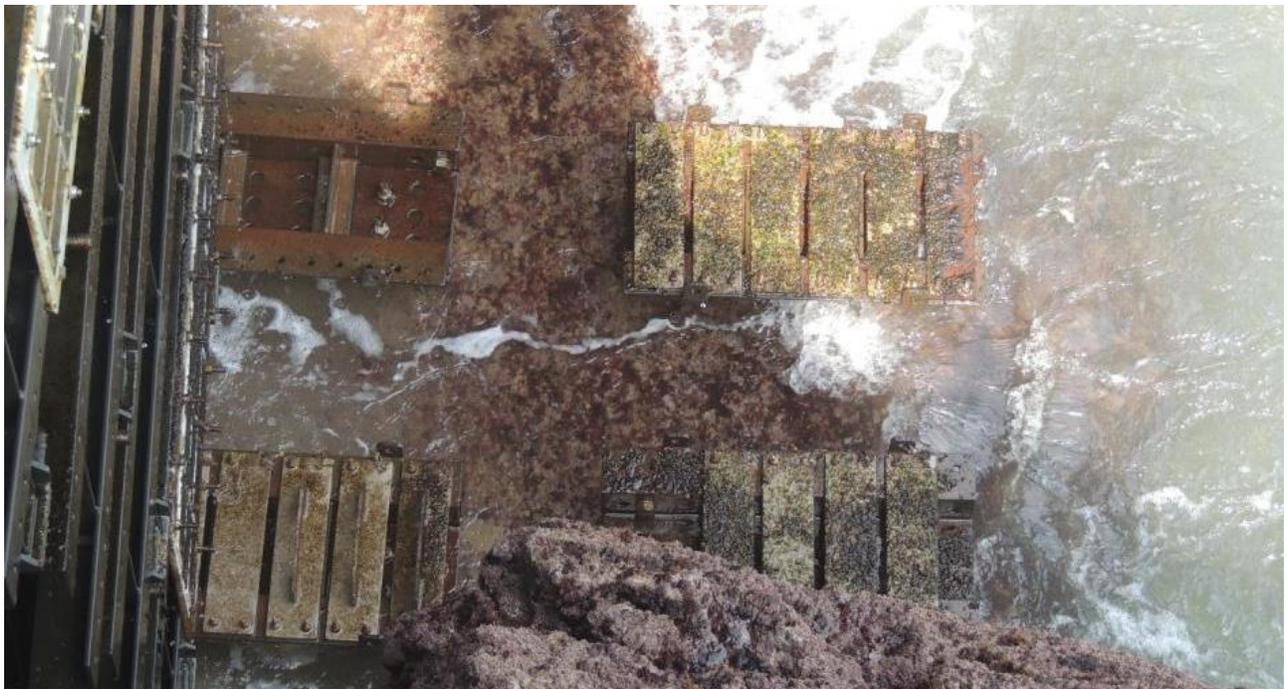
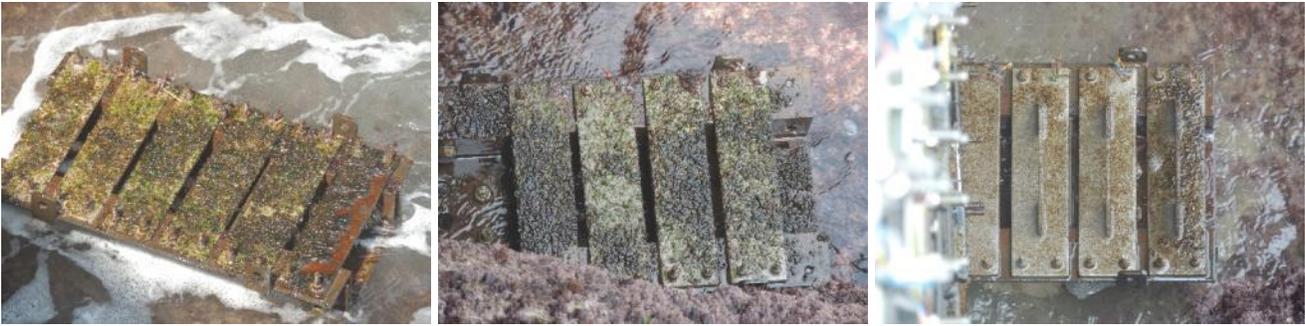
Submerged: Figure 29 and Figure 30 show a big difference in the presence of algae compared to the previous month (M2). There were a lot of seaweed in all coupons except in the ones which were more hidden from the sun. Not only brown algae appeared attached to the samples as before, images taken in M3 showed green algae too for the first time.

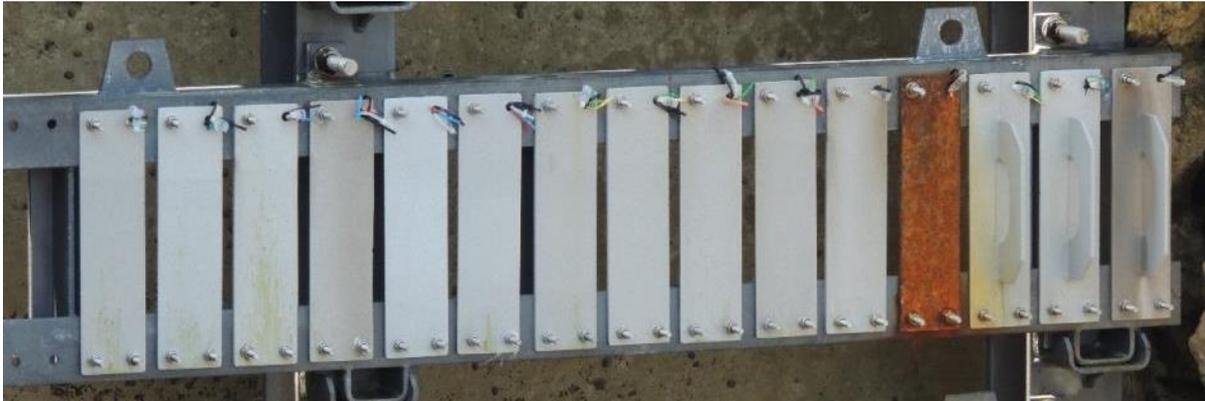
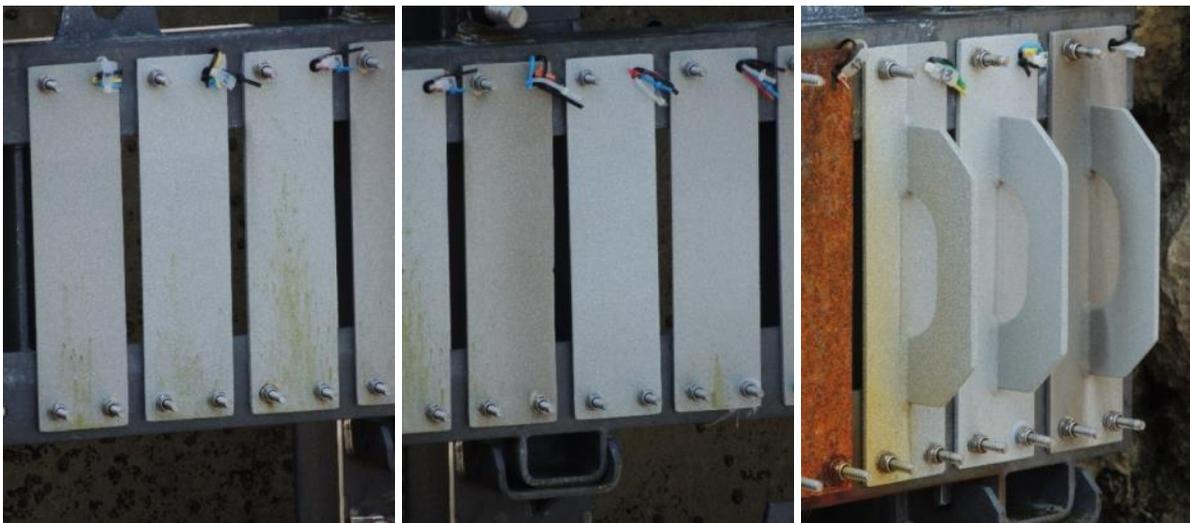
Splash: there was no a big variation from M3 in the coupons of this exposure zone: algae observed in C1, C2 and C3. Some spots were observed in C13 coming probably from contamination from the rust in C12 (bare steel). Figure 31 shows a general view of all the specimens in the splash zone and Figure 32 shows in detail the samples mentioned before.

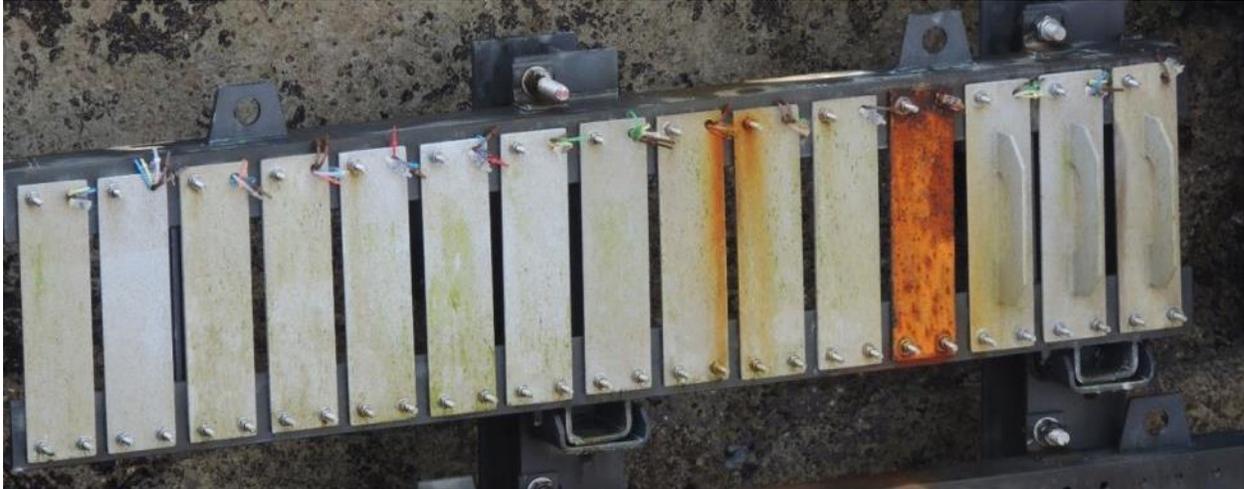
Tidal: Figure 33 shows that C17 was the only coupon that did not have algae on its surface. The three welded coupons had algae although C30 was the sample which had more spots on the handle (see Figure 34). C24 and C25 had rust spots (see Figure 35) coming from C12. C12 was completely oxidized and was just over them as it can be observed in Figure 36.

Figure 33: Samples in the tidal zone in M4

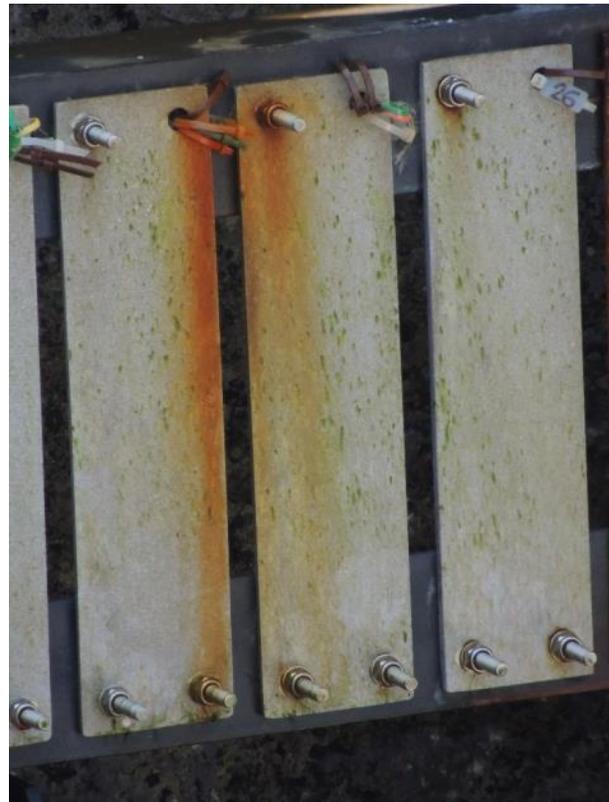
Figure 35: Rust spots on C24 and C25

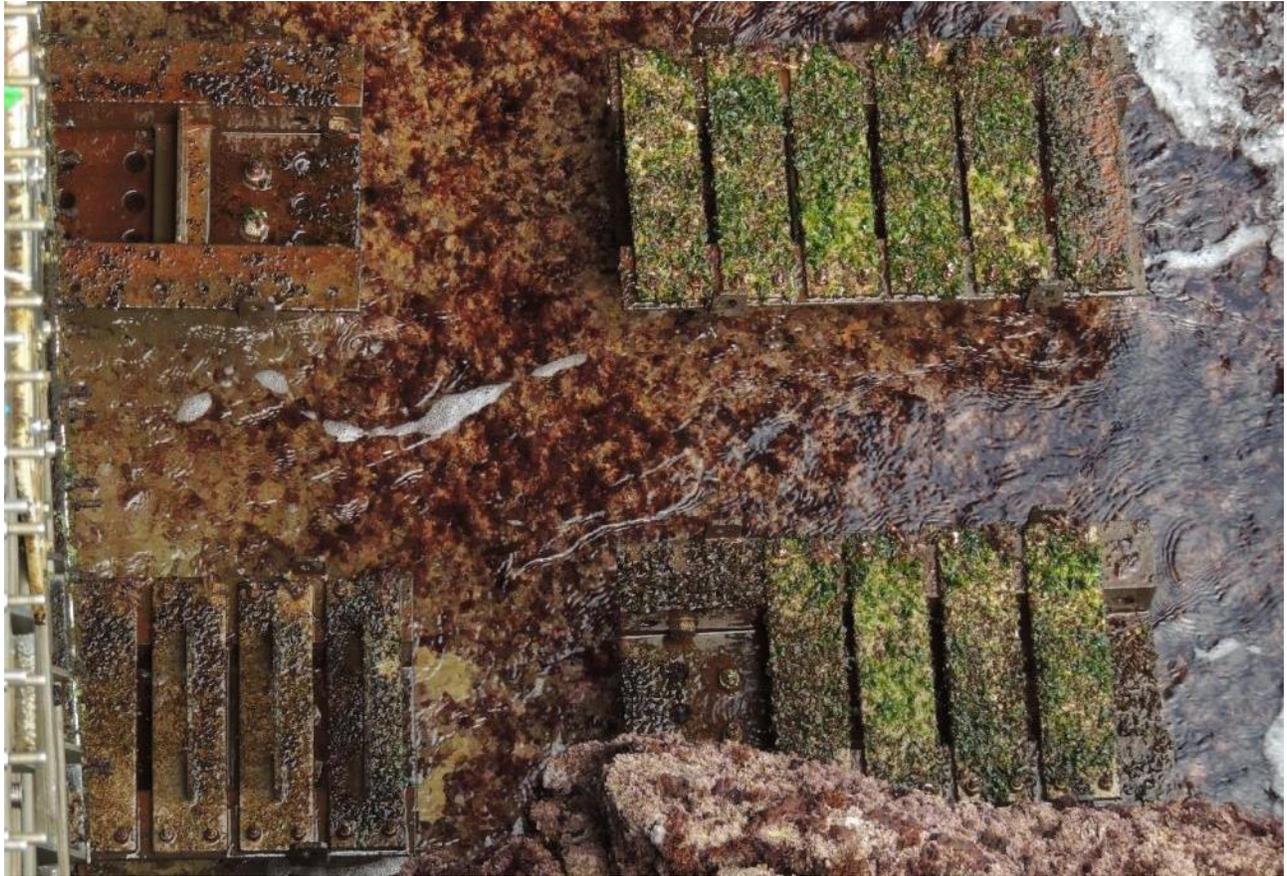
Submerged: Figure 37 shows lots more sea lettuces in this exposure zone than in M3. There was an important increase of the quantity of algae in these coupons. Even in this period of time this growth was noted. Figure 38 shows the difference in the state of the samples in a period of 17 days.

Figure 37: Samples in submerged zone in M4

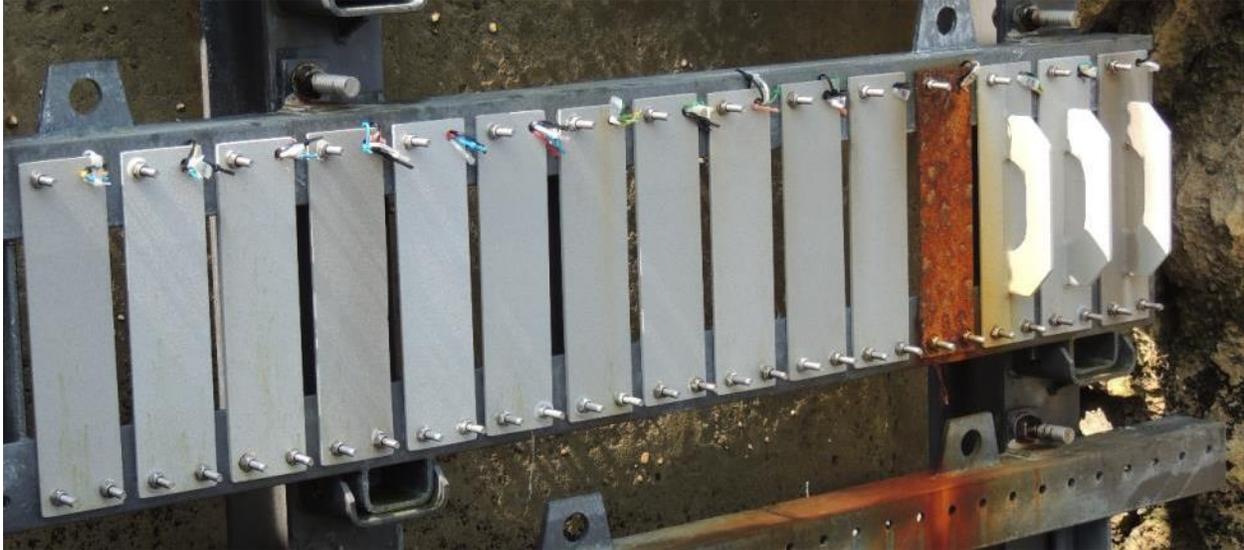
Splash: Figure 39 shows that there was not a big variation of the state of the coupons from M4 in this exposure zone. Very little traces of algae were observed in C1, C2, C3 and C6. Some spots of rust were observed in C13 which probably have their origin in the rust originated in C12.

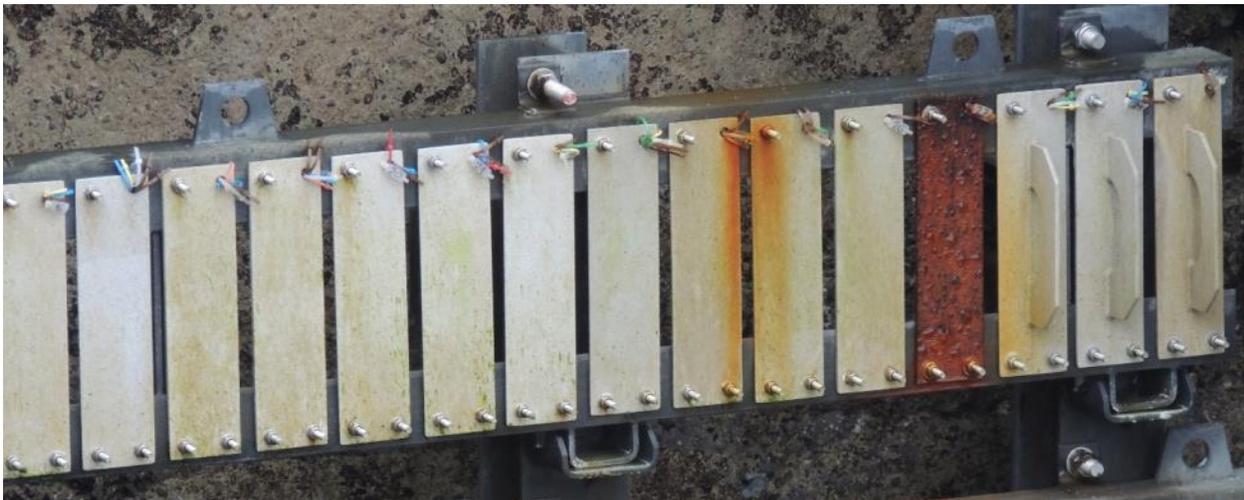
Tidal: Figure 40 shows that C17 was the only coupon that did not have algae in its surface. The three welded coupons had algae in all their surfaces. C24 and C25 had rust coming from C12. C12 is completely oxidized and is just over them. At this point, C12 was moved to the left of C1 to avoid more contamination. Of this way the rust spreaded by C12 would not fall over any coupon.

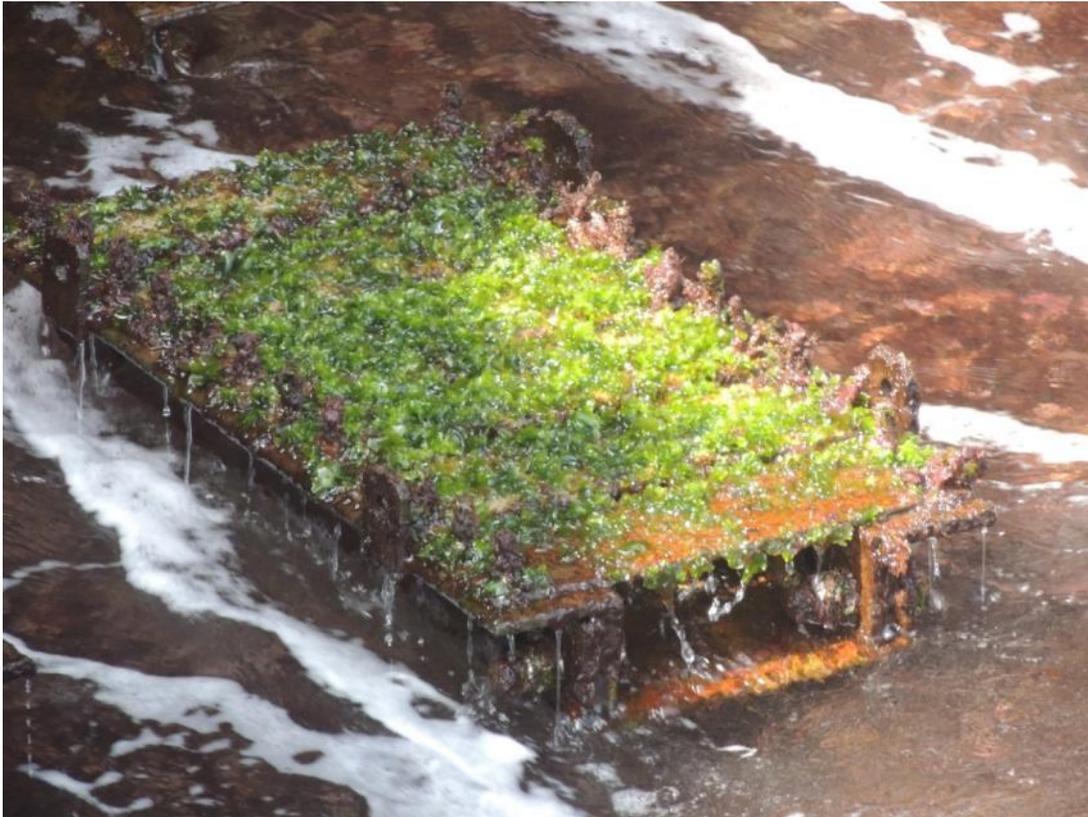
Submerged: Figure 41 shows that the quantity of sea lettuce was similar than in M4. There was no evolution of the quantity of algae in these coupons during this month.

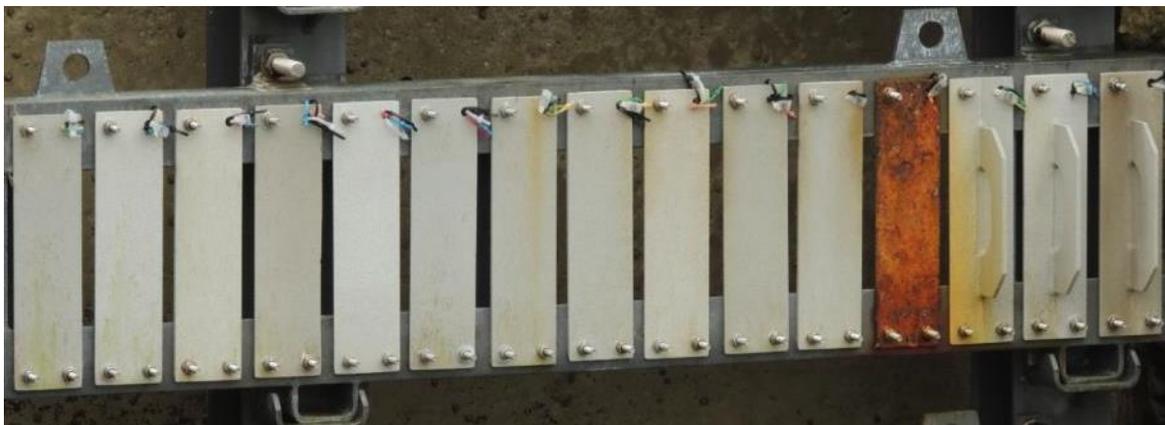
Splash: The presence of very little traces of algae are showed in Figure 42 (C1, C2, C3 and C6) although they were progressively disappearing. The reason of that could be the increase of temperature of the last weeks.

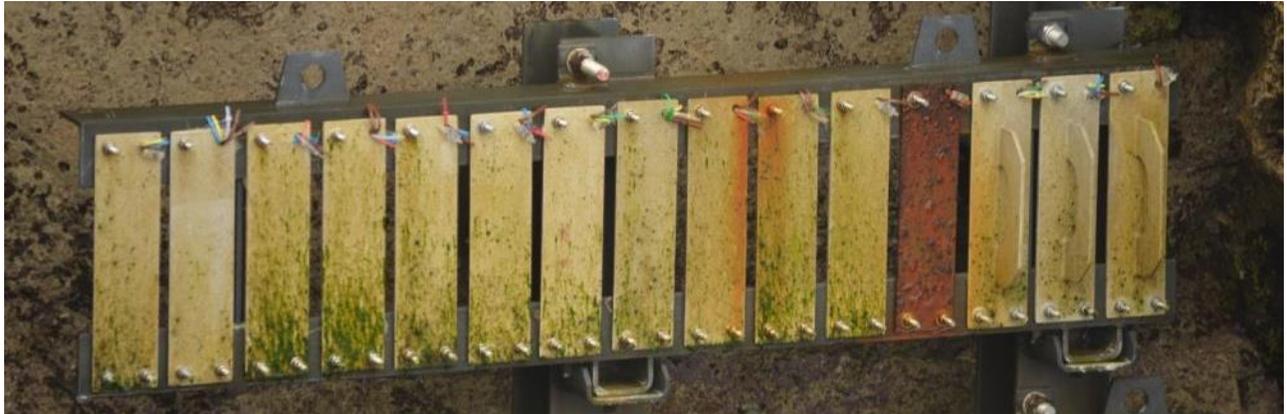
Tidal: Figure 43 shows a significant increase of the presence of algae in the coupons in this exposure zone respect to M5. C18 and C19 were the coupons that had more algae and C17 continued being the one less affected by algae.

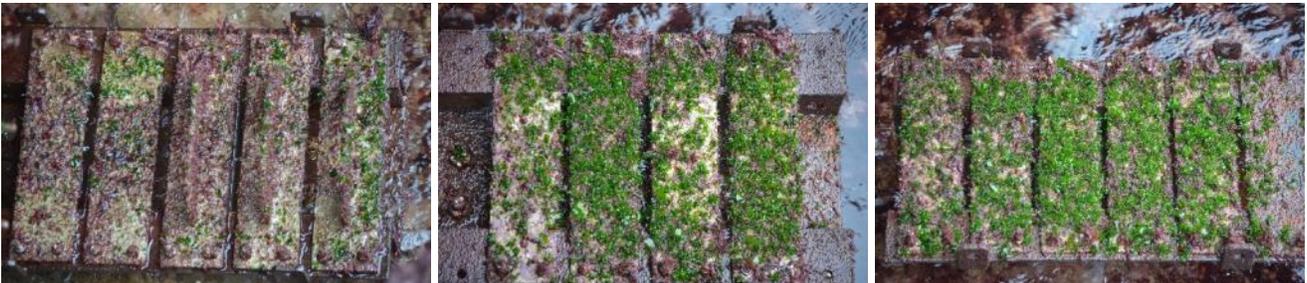
Submerged: Figure 44 shows that the quantity of green algae in the coupons during this month was similar to the previous month (M5). There was an important difference of seaweed between the samples closer to wall of the MCTS El Bocal (Figure 44 left) and the two closer to the sea and further to the wall (Figure 44 middle and right). This difference in the seaweed growth may be due to the amount of time they were exposed to the sun was not the same. The ones closer to the wall, even being really close to the other ones, were in a gloomier area.

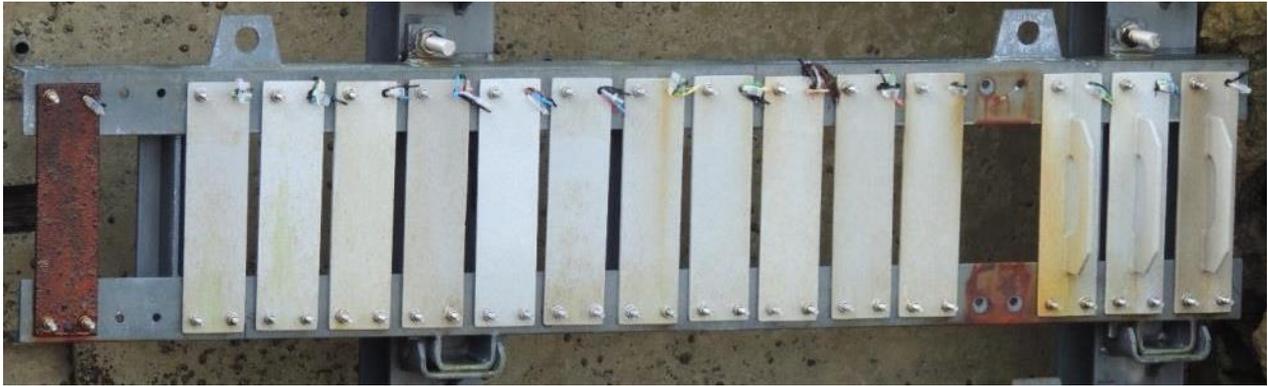
Splash: Figure 45 shows the presence of some traces of algae although they were progressively disappearing, probably because of the increase of temperature during the previous weeks or due to less wet time. C12 was removed from where it was fixed and it was set to the left side of the frame to ensure samples below it were not contaminated further.

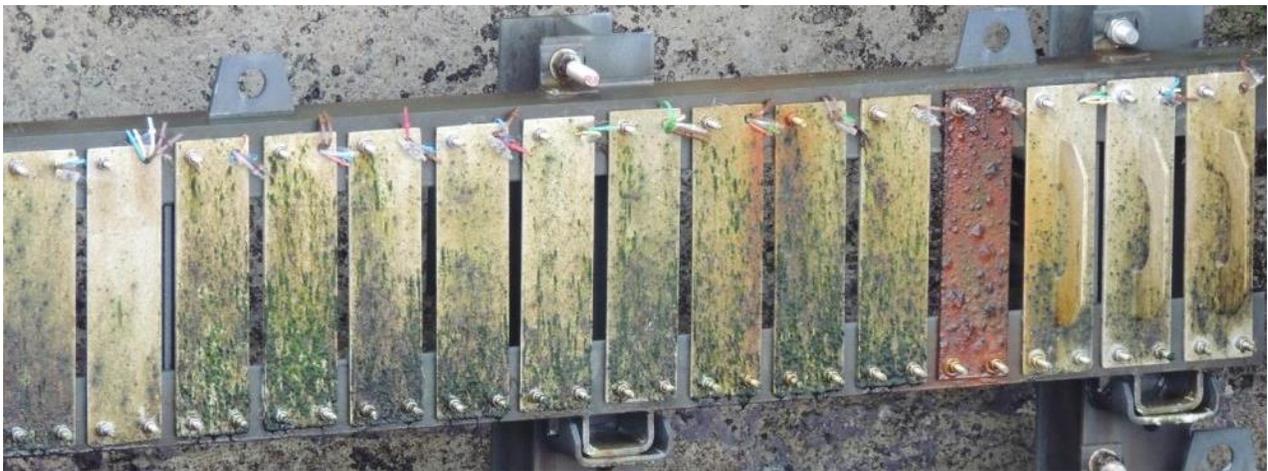
Tidal: Figure 46 shows a significant increase of the presence of algae in the coupons in this exposure zone respect to M6. Most coupons were covered almost entirely by algae C17 was the sample that continued being least affected by algae.

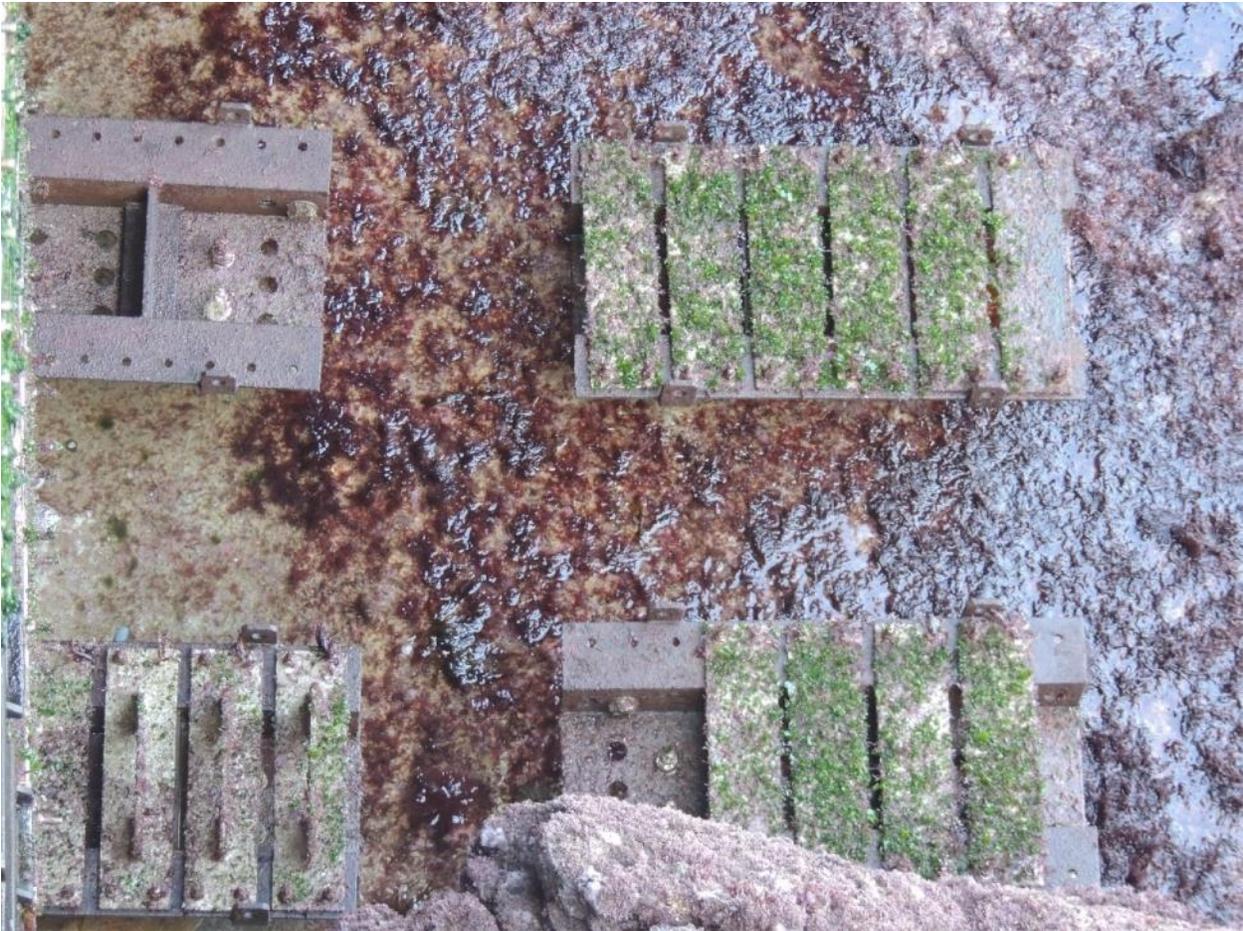
Submerged: Figure 47 shows that the quantity of sea lettuce in the coupons during this month was similar to the previous month (M6). As in the previous month, there was an important difference of seaweed between the samples closer to wall of the MCTS El Bocal and the two closer to the sea and further to the wall.
