ACORN

Advanced Coatings for Offshore Renewable Energy

Deliverable D5.1: At least one coating from WP3 has been successfully demonstrated in a marine environment and has exhibited fouling and seawater corrosion resistance over one summer season.

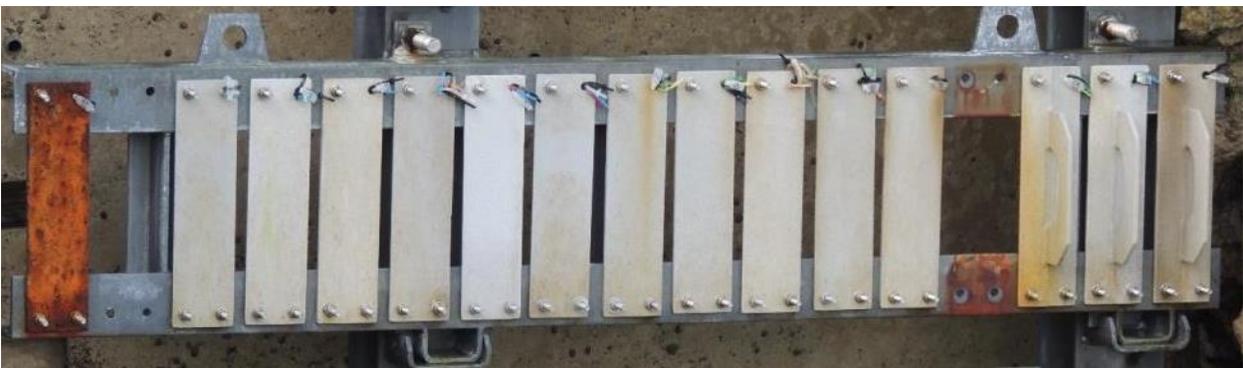
Splash: The state of the coupons in this exposure zone was the same as in the previous month (see Figure 48).

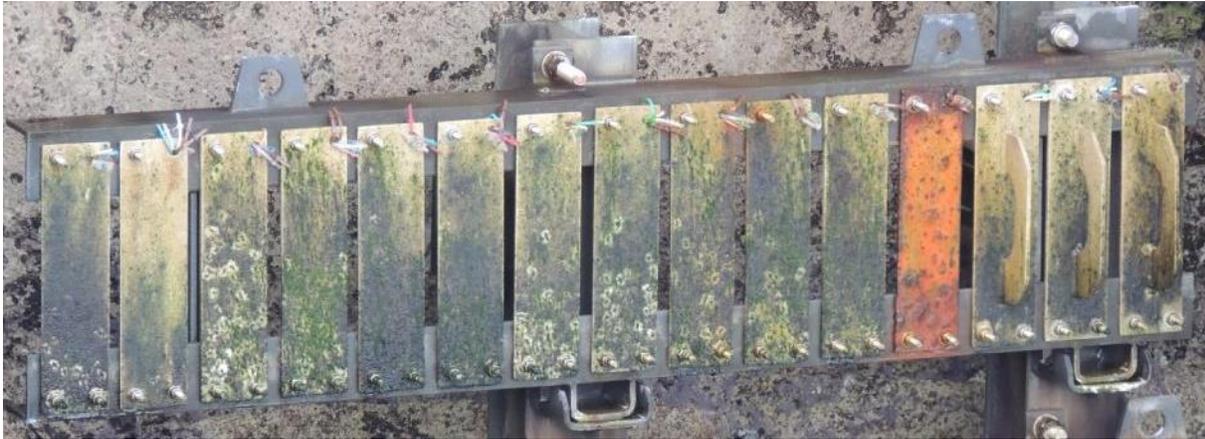
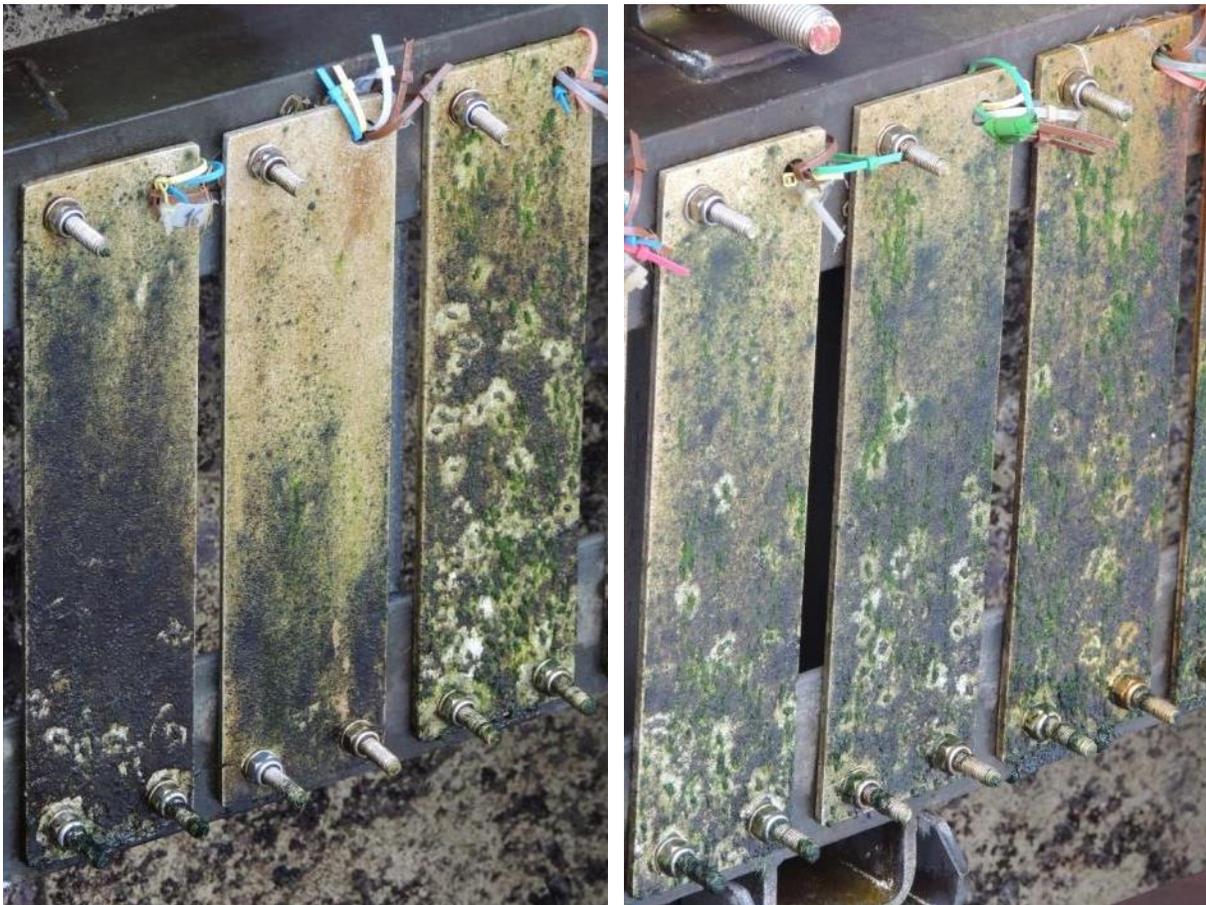
Tidal: Figure 49 shows a significant increase of the presence of algae in the coupons in this exposure zone with respect to M7. Besides algae, it was noted that some coupons, as C16, C18, C19, C22, C23, C24 and C25, had other organisms fixed to them (see Figure 50 for a detailed view).

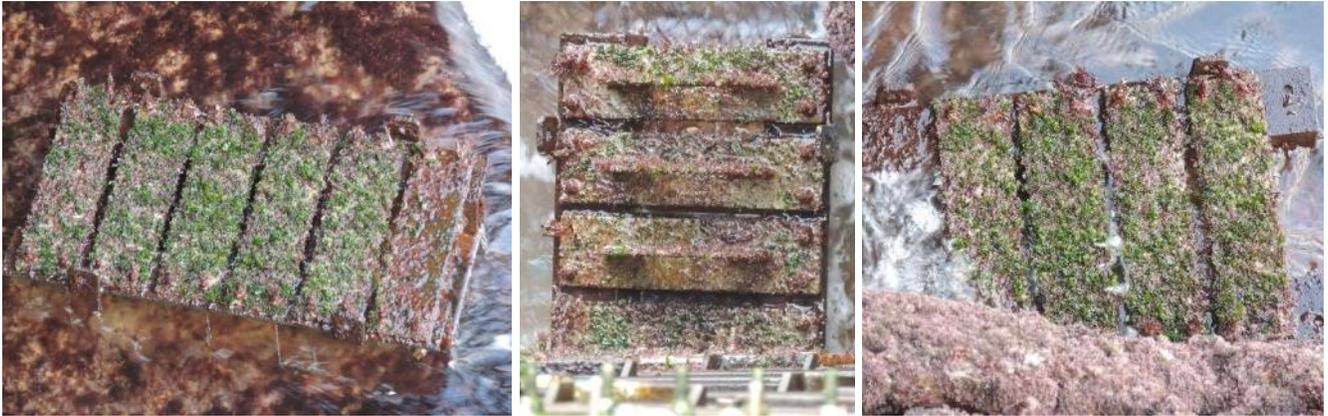
Submerged: Figure 51 shows that, in addition to the green algae that were already set in the samples in M7, some brown algae were identified. The amount of brown algae was higher in the samples closer to wall of the MCTS EI Bocal (image on the middle) than in the others.

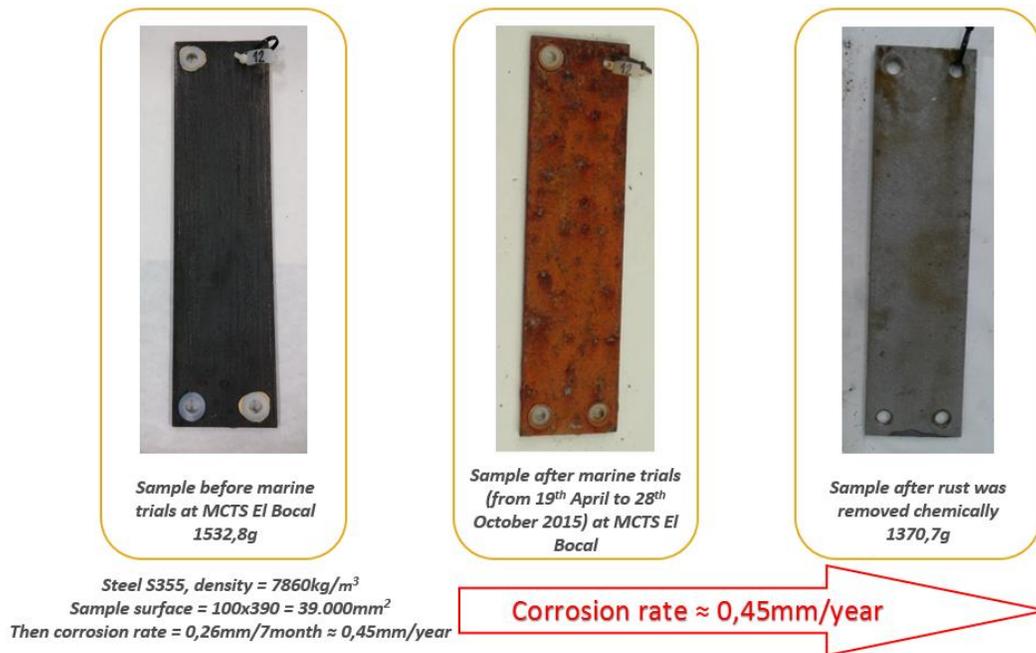
All coatings showed good behavior against corrosion, none of the samples were affected by this surface degradation effect. Some of them had rust spots but this rust was coming from bare steel coupons situated vertically above them. The corrosion rate was less than $3\mu\text{m}/\text{yr}$ for any coupon. This value of corrosion rate is very low compared with the rate of the bare steel coupons. Figure 56 shows the corrosion rate of the bare steel sample exposed in the splash zone during the tests performed at the MCTS EI Bocal.

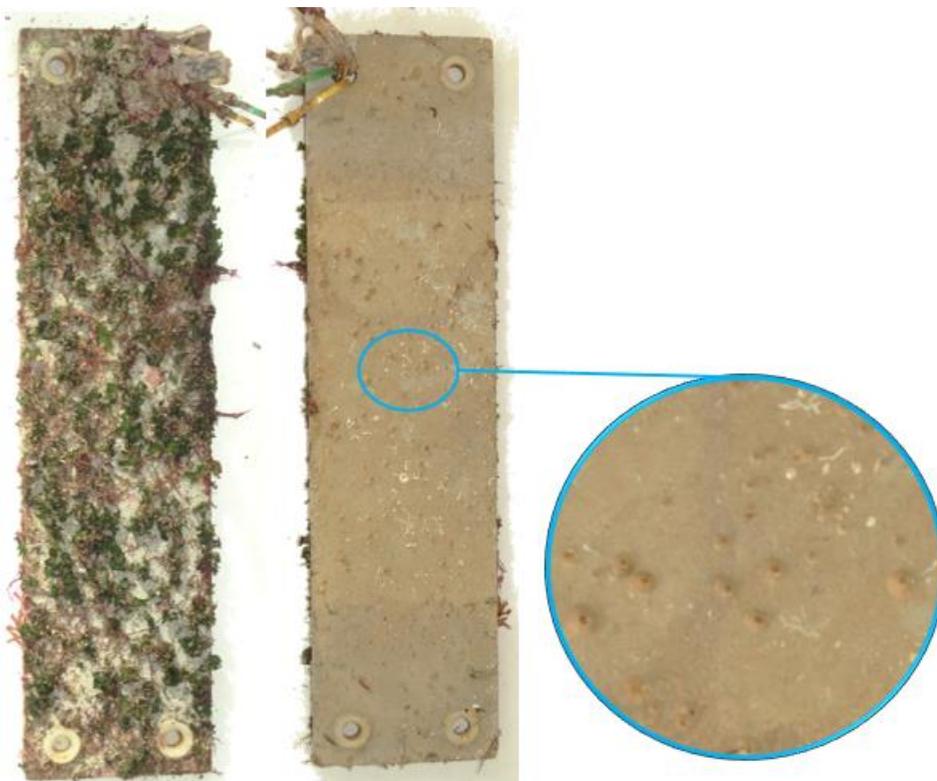
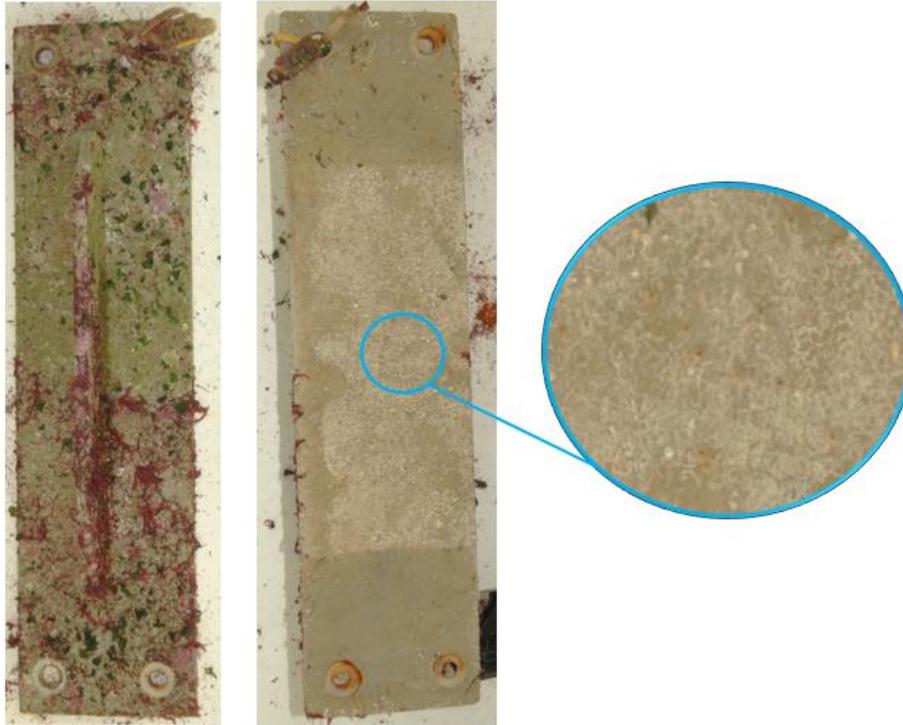
The back faces of the samples were not protected with ACORN coatings, they were coated with TSA. The samples exposed in the submerged zone presented some juvenile barnacles attached to these faces. Also bryozoan were fixed to these faces. Two examples of these facts are Figure 57 and Figure 58, where both faces of two submerged samples are shown.

Figure 57: Upper face (left) and bottom face (right) of C38 after marine trials

Figure 58: Upper face (left) and bottom face (right) of C43 after marine trials

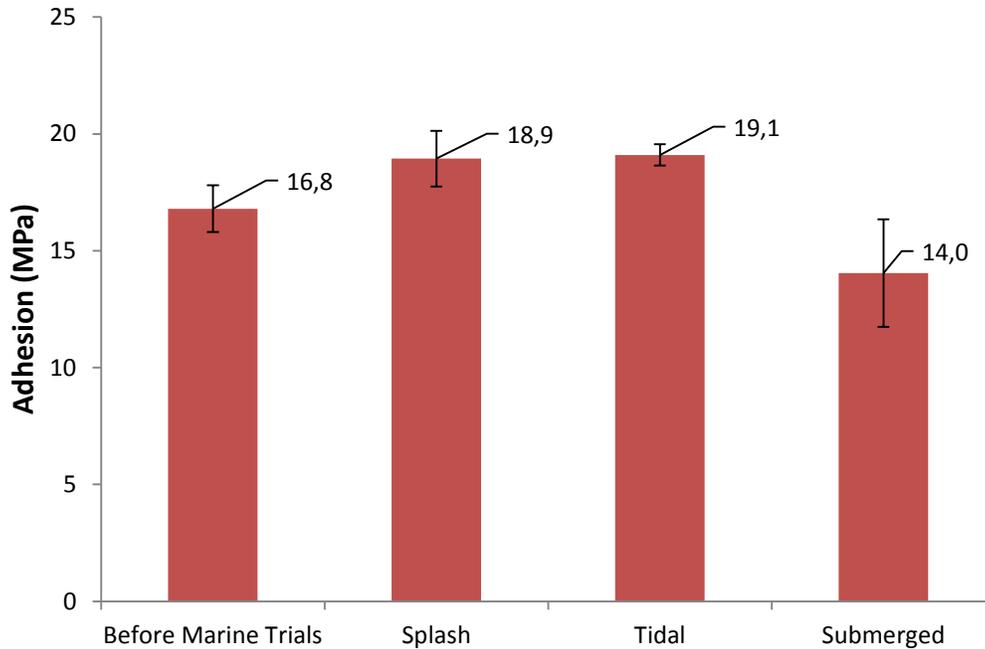
Several tests were carried out in each sample to obtain an average adhesion value. The results of these tests are shown in Figure 60. The performance of the tests is explained as follows:

- Splash: all tests mainly failed at glue-coating interface which represents a lower bound of the coating-substrate bond strength
- Tidal: all tests had an adhesive failure in the glue
- Submerged: a lower average value obtained likely due to bond pull testing pulling off corrosion products from surface of coating rather than pulling coating from substrate
