ACORN

Advanced Coatings for Offshore Renewable Energy

Deliverable D5.1: At least one coating from WP3 has been successfully demonstrated in a marine environment and has exhibited fouling and seawater corrosion resistance over one summer season.

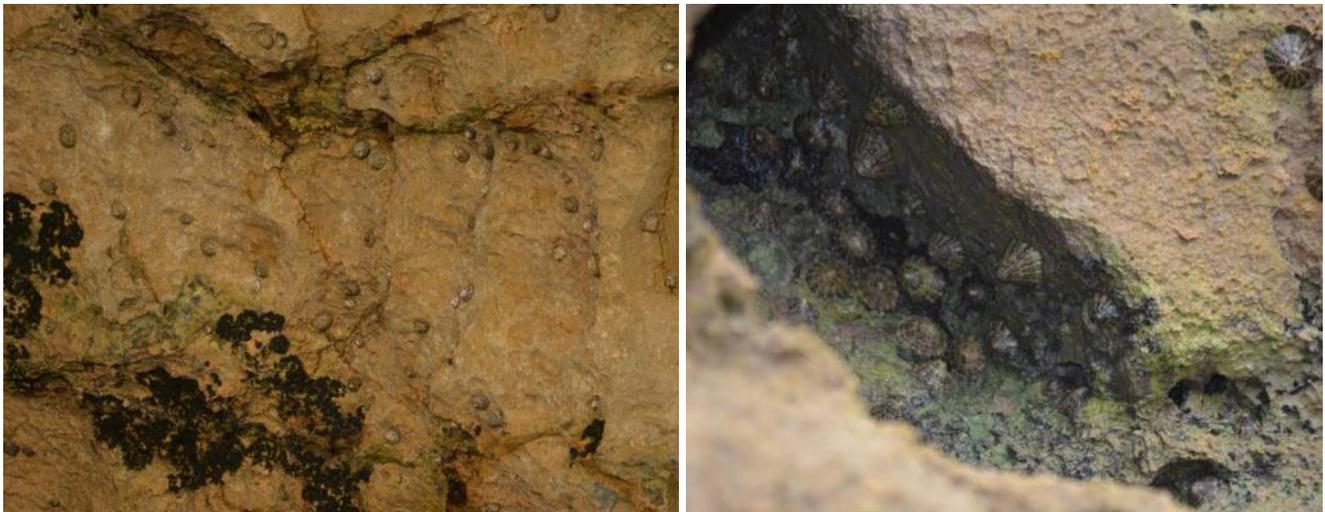
MCTS EI Bocal was selected for the marine trials because it was considered an ideal test site for corrosion and fouling studies. Figure 4 is one example of the presence of fouling while the marine trials were carried out. It shows some limpets attached to the rocks around the metallic structure used to fix the samples tested.

Figure 4: Limpets settled to rocks around the structure where samples were tested

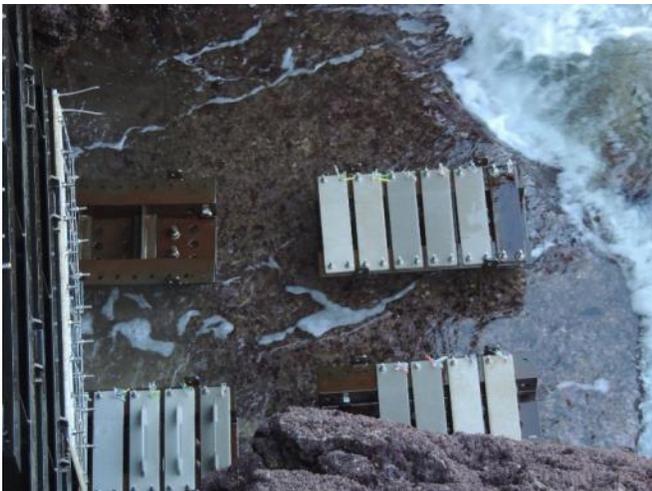
Figure 13: Samples in submerged zone 18 days after installation

Submerged: Figure 14 shows a substance similar to mud covering all the specimens. No green algae were present on these coupons. The quality of the image is not so good due to the weather conditions

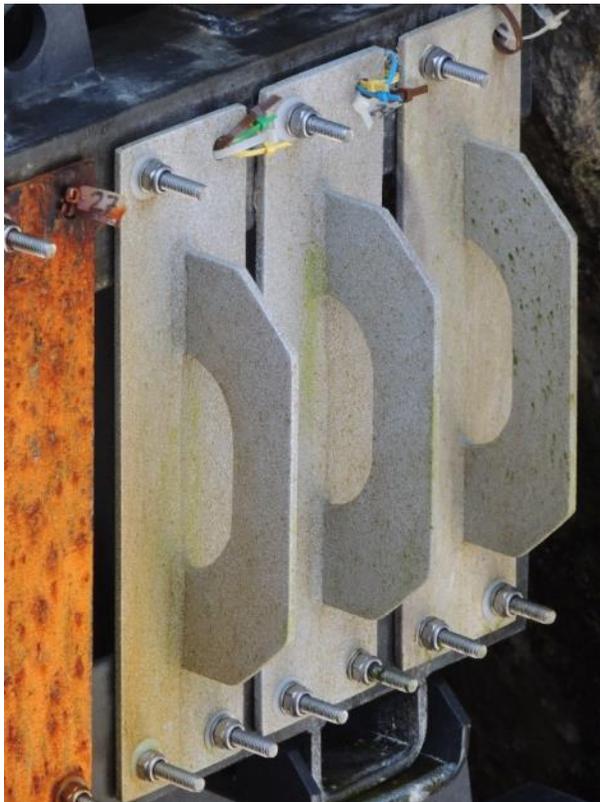
Tidal: Figure 33 shows that C17 was the only coupon that did not have algae on its surface. The three welded coupons had algae although C30 was the sample which had more spots on the handle (see Figure 34). C24 and C25 had rust spots (see Figure 35) coming from C12. C12 was completely oxidized and was just over them as it can be observed in Figure 36.

Figure 34: Three welded coupons in tidal zone

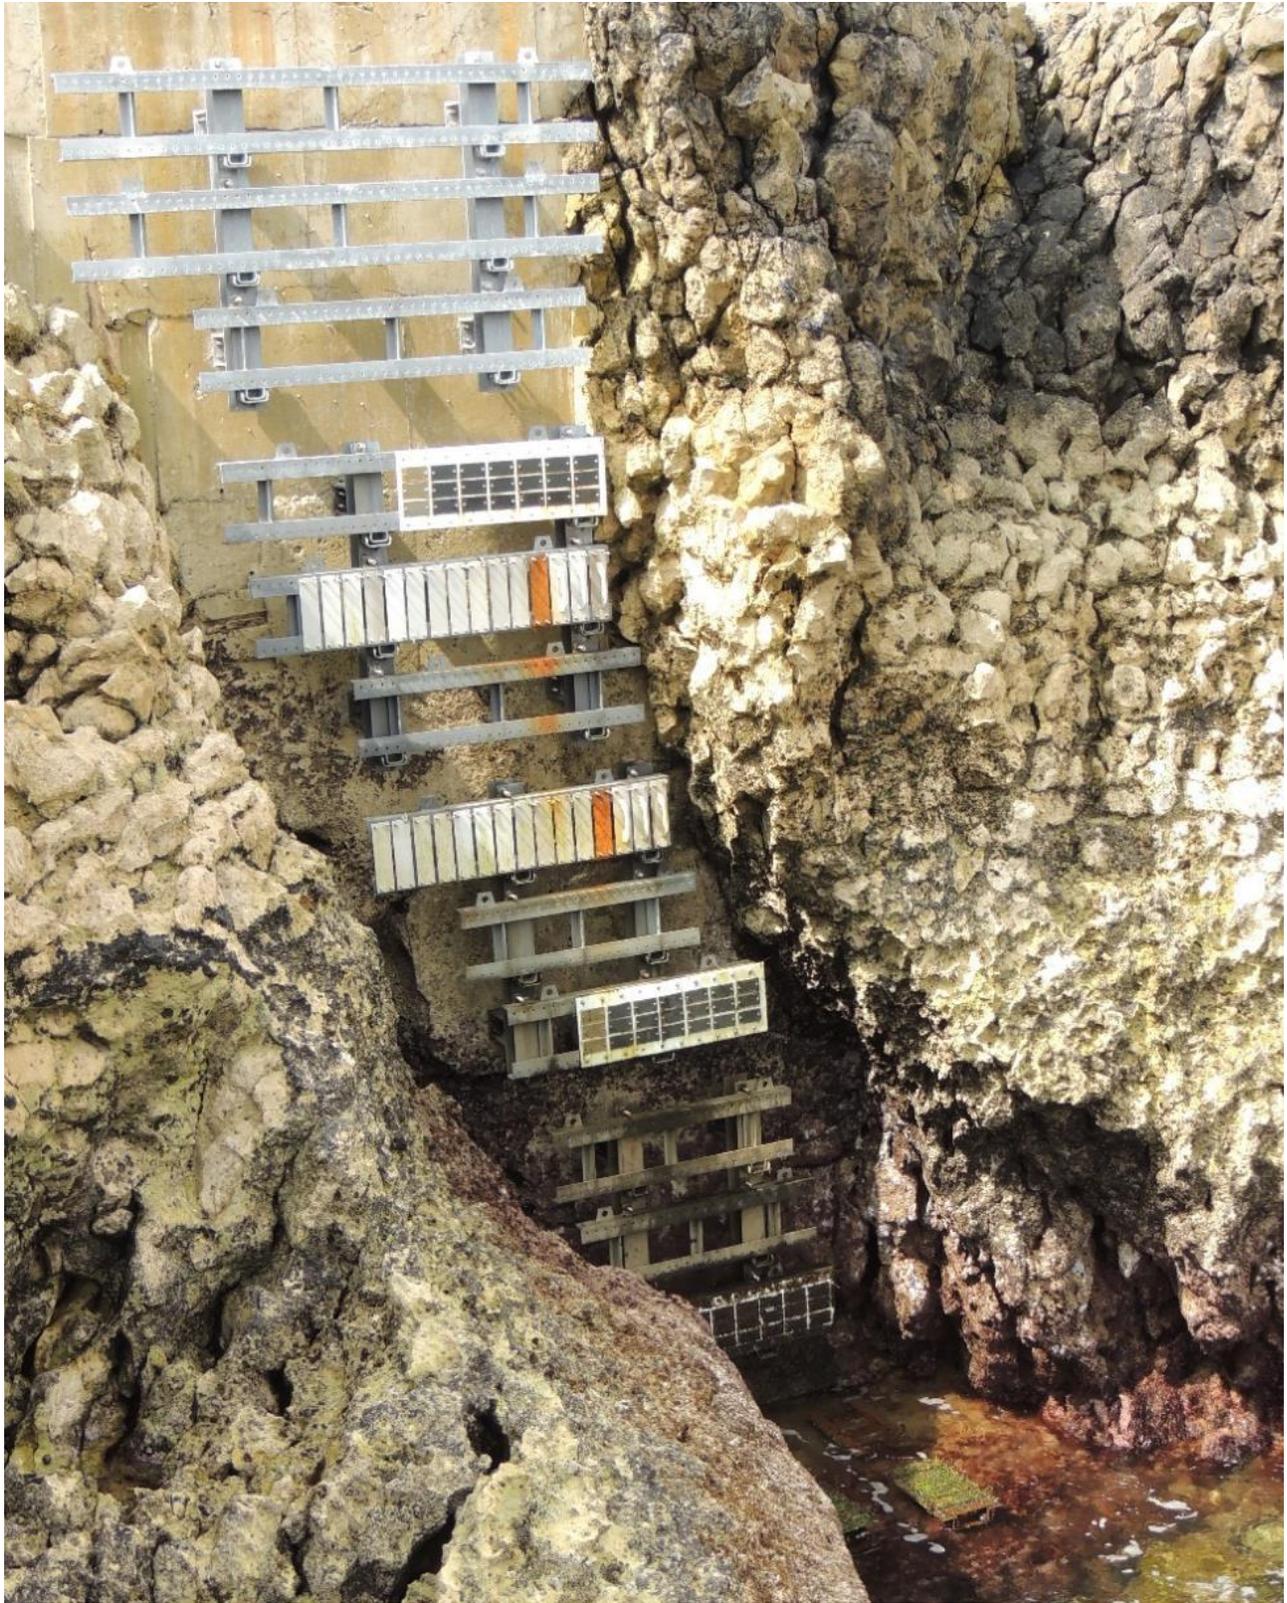
Figure 36: General overview of the samples in M4

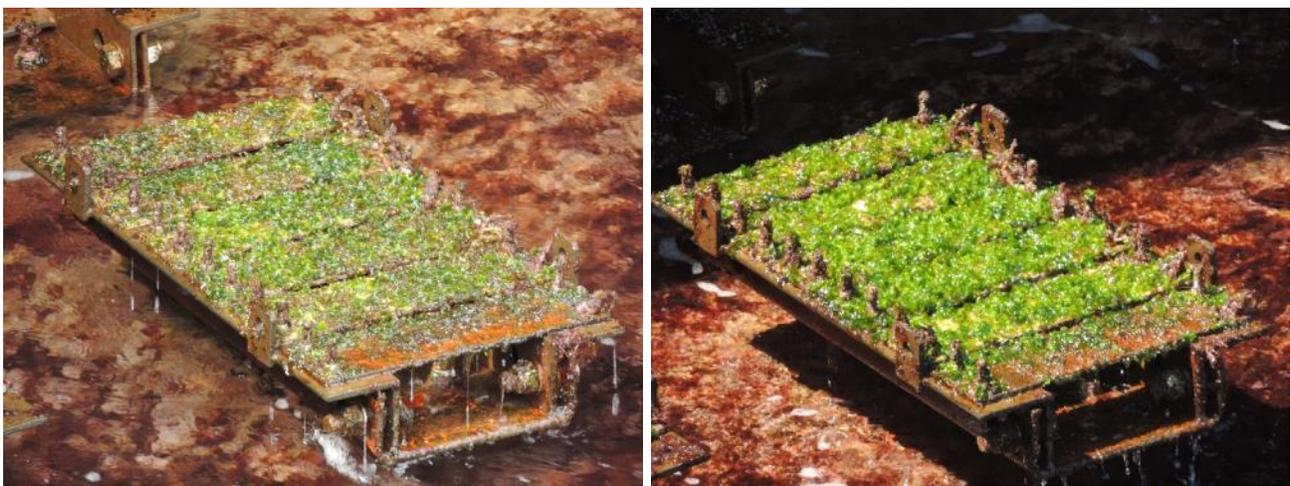
Submerged: Figure 37 shows lots more sea lettuces in this exposure zone than in M3. There was an important increase of the quantity of algae in these coupons. Even in this period of time this growth was noted. Figure 38 shows the difference in the state of the samples in a period of 17 days.

Figure 38: Evolution in 17 days time

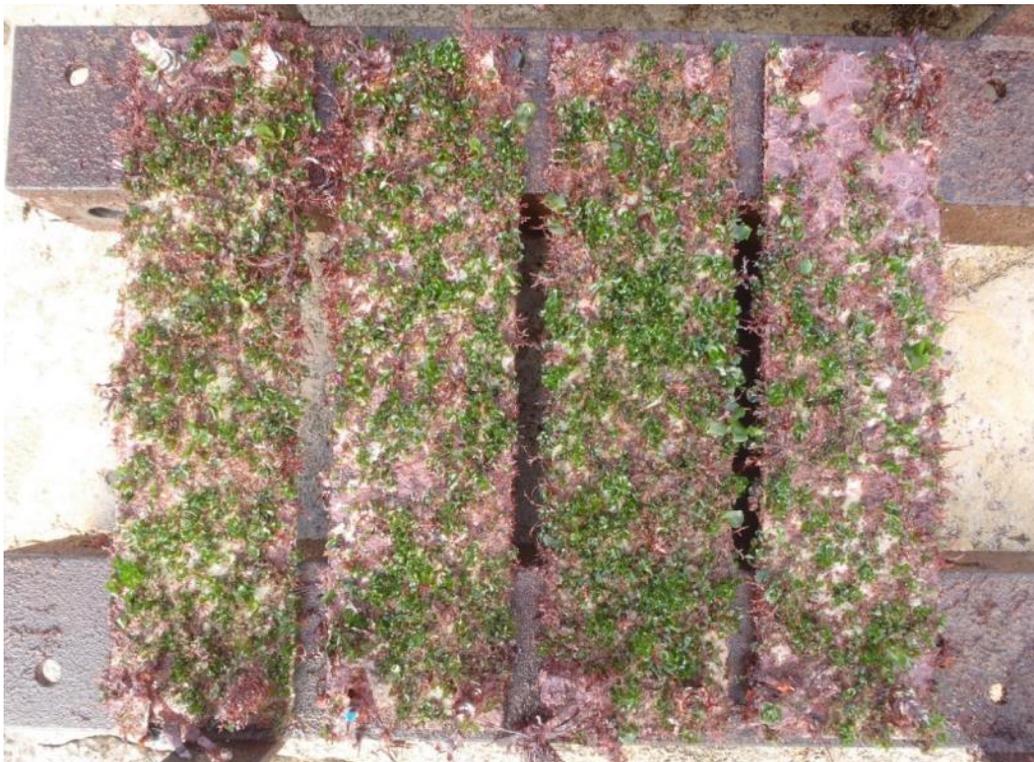
Figure 52: Samples C33, C34, C35 and C36 the day of the decommissioning

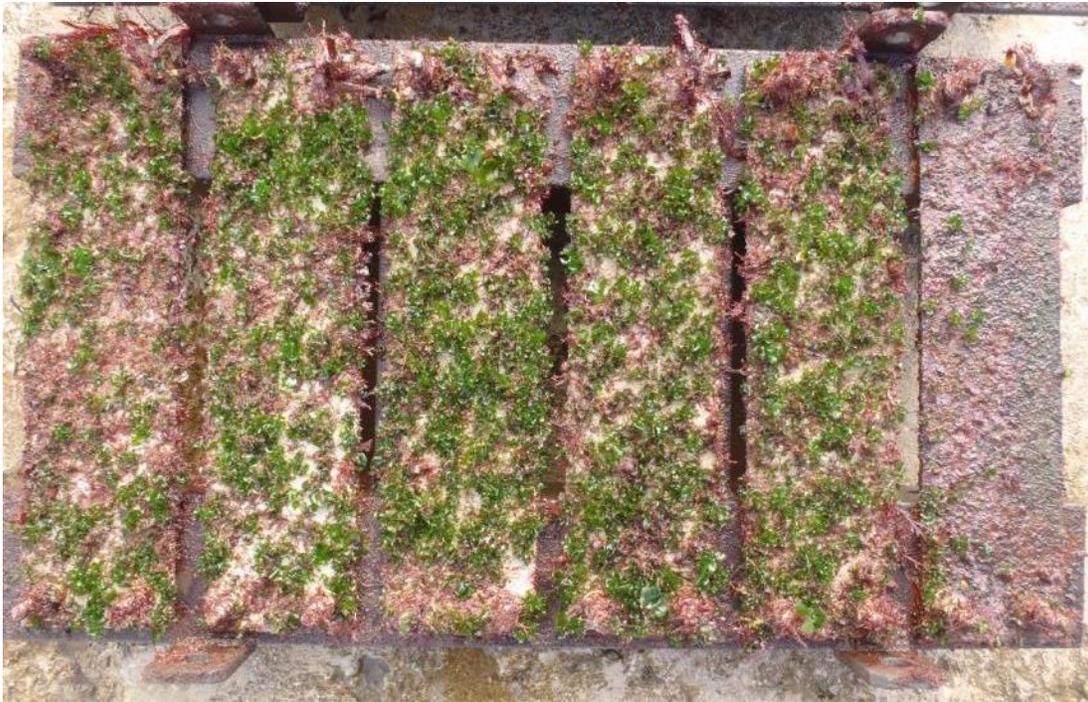
Figure 53: Samples C37, C38, C39, C40, C41 and C42 the day of the decommissioning

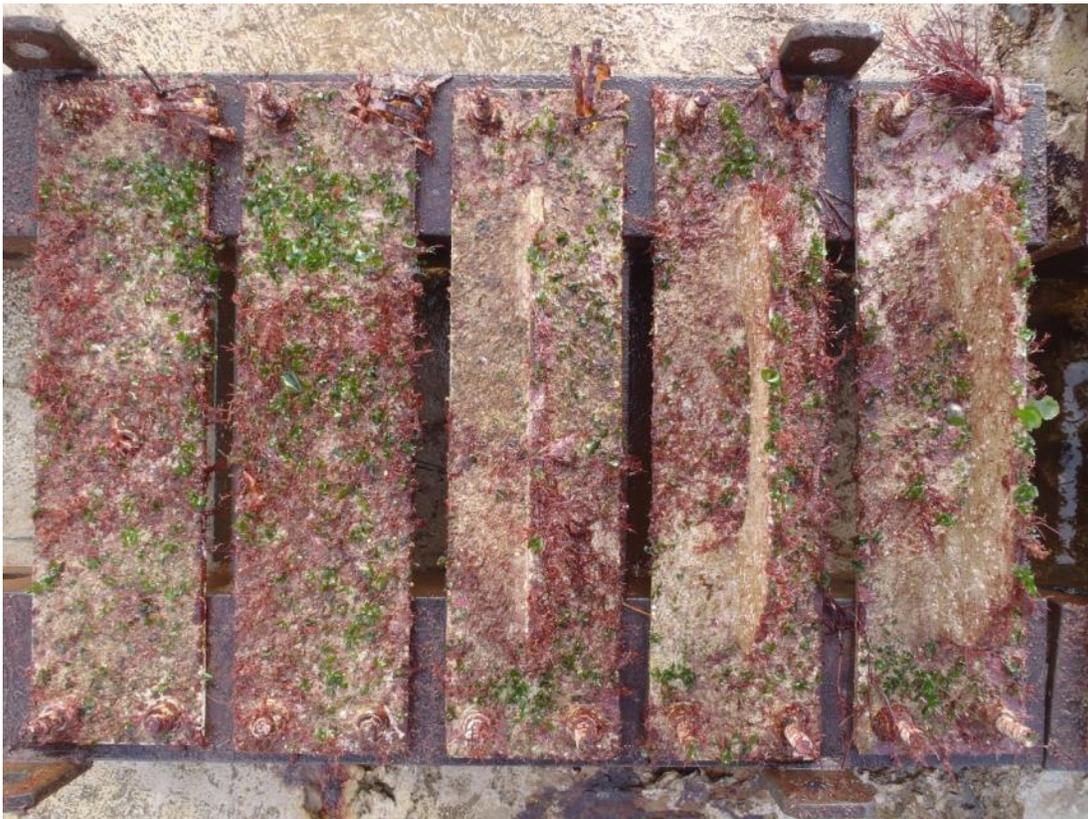
Figure 54: Samples C31, C32, C43, C44 and C45 the day of the decommissioning

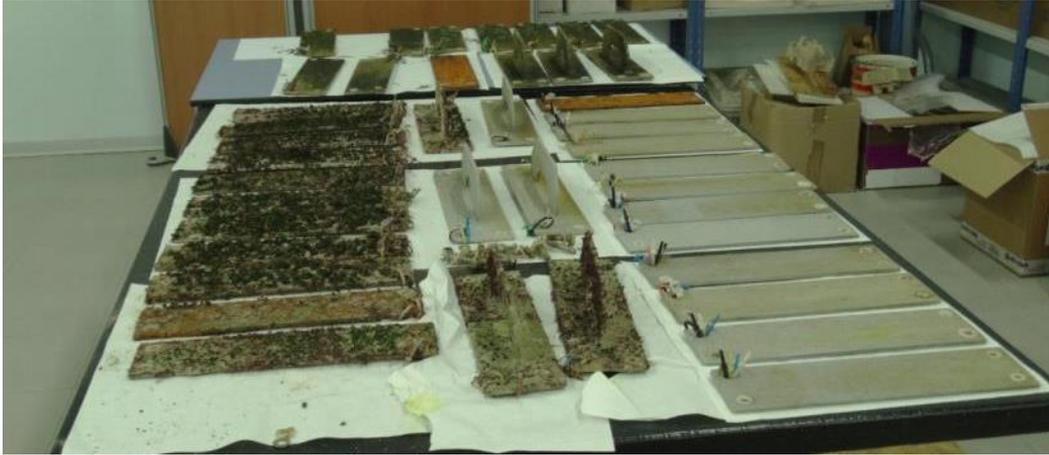
Figure 55: Samples in the laboratory after the marine trials

All coatings showed good behavior against corrosion, none of the samples were affected by this surface degradation effect. Some of them had rust spots but this rust was coming from bare steel coupons situated vertically above them. The corrosion rate was less than $3\mu\text{m}/\text{yr}$ for any coupon. This value of corrosion rate is very low compared with the rate of the bare steel coupons. Figure 56 shows the corrosion rate of the bare steel sample exposed in the splash zone during the tests performed at the MCTS EI Bocal.

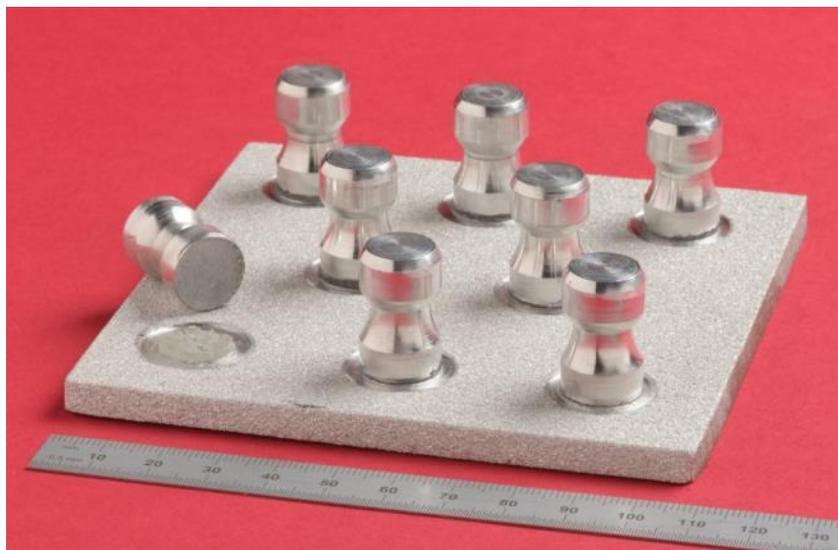
Adhesion tests were carried out on the next three samples: C11 (splash), C26 (tidal) and C41 (submerged). To assess the adhesion of the coatings, pull-off testing was carried out following the standard ASTM 4541 [2]. Figure 59 shows the preparation of the sample and the dollies to run the tests. TSA adhesion greater than 6.89MPa is required by NACE 12 [3] for thermal spray coatings. For example, the typical adhesion for paint is around 3MPa.

Figure 59: Dollies glued to run an adhesion test

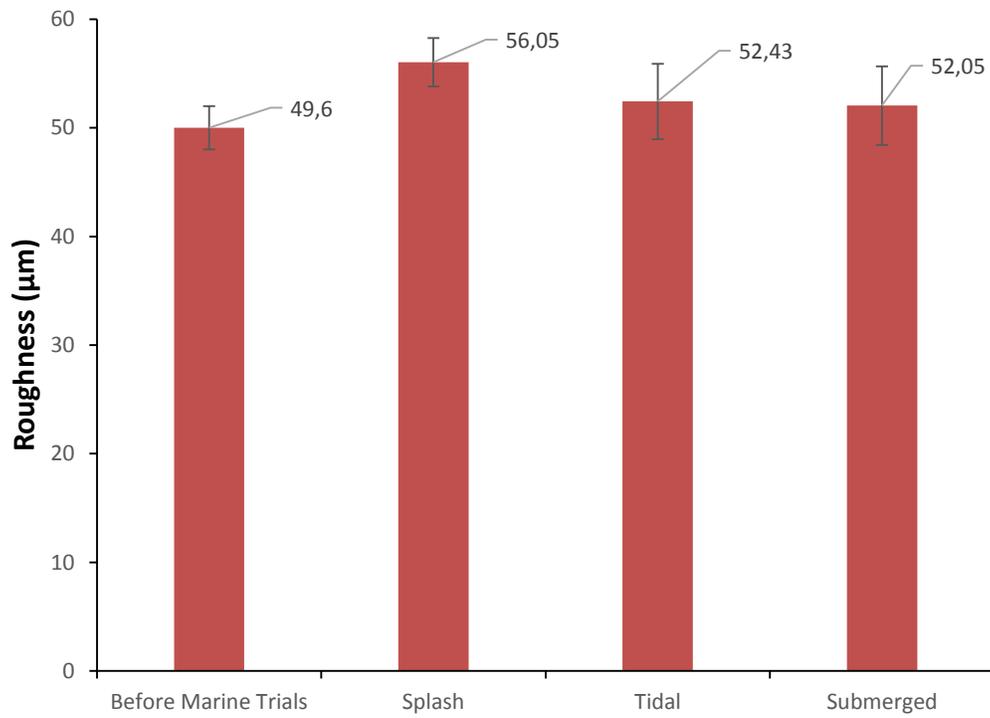
To run the roughness tests a focus variation microscopy was used to generate a 3D scan of the surface (Figure 61). The average roughness of the samples before the marine trials is $\sim 50\mu\text{m}$, a higher value than a regular TSA coating. The results of the tests are shown in Figure 62.

Figure 62: Roughness tests before and after marine trials
